# Crail Coastal Path- Erosion Protection

## Inspection Survey Report

September 2024

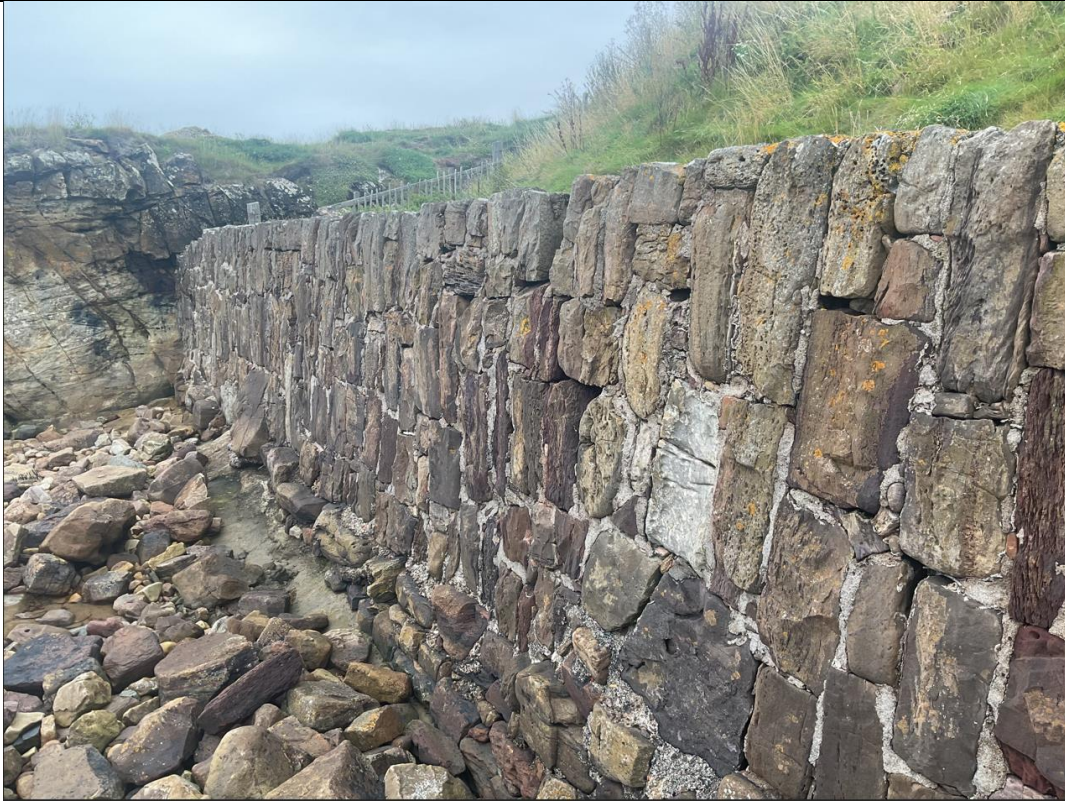
<b>Wall Section</b>	<b>Degree of damage</b>	<b>Wall height and depth</b>	<b>Observations</b>	<b>Figures</b>
0m-23.5m	2	2.4m height, 0.6m depth	Mortar washout between stones. Blocks still intact and no structural support absent.	Figures 1 and 2

*Figure 1- General condition of the wall between ch000-ch23.5.*

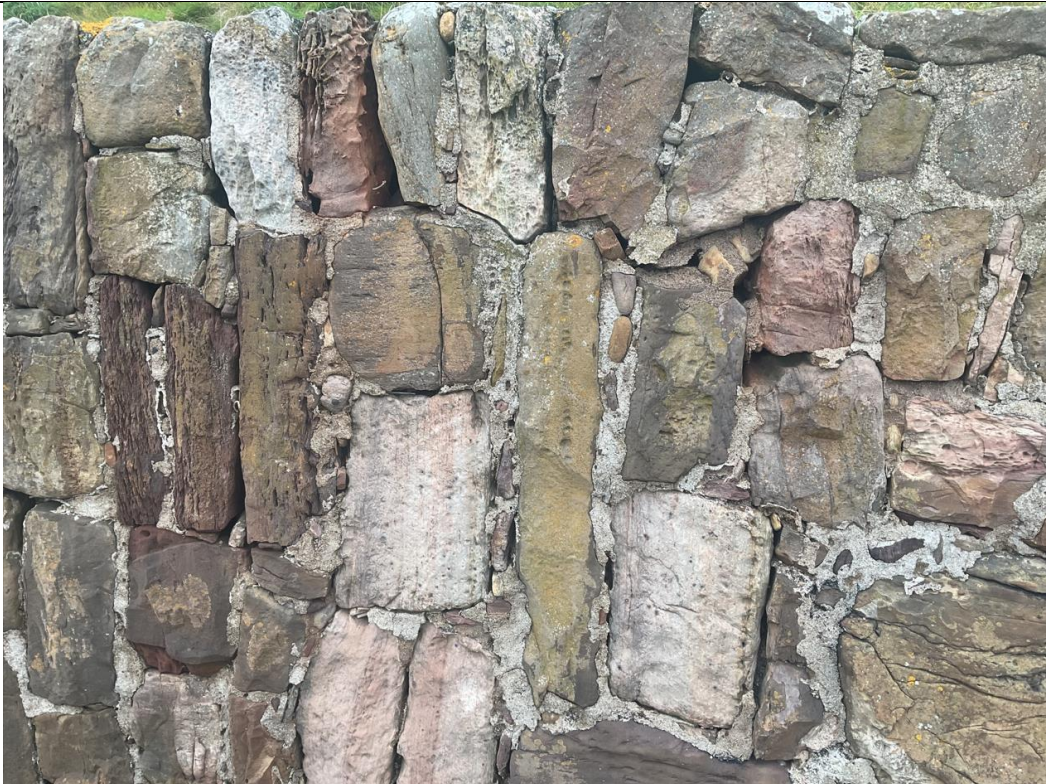
*Figure 2- Closer condition of weathered stones and mortar representative of ch000-ch23.5.*

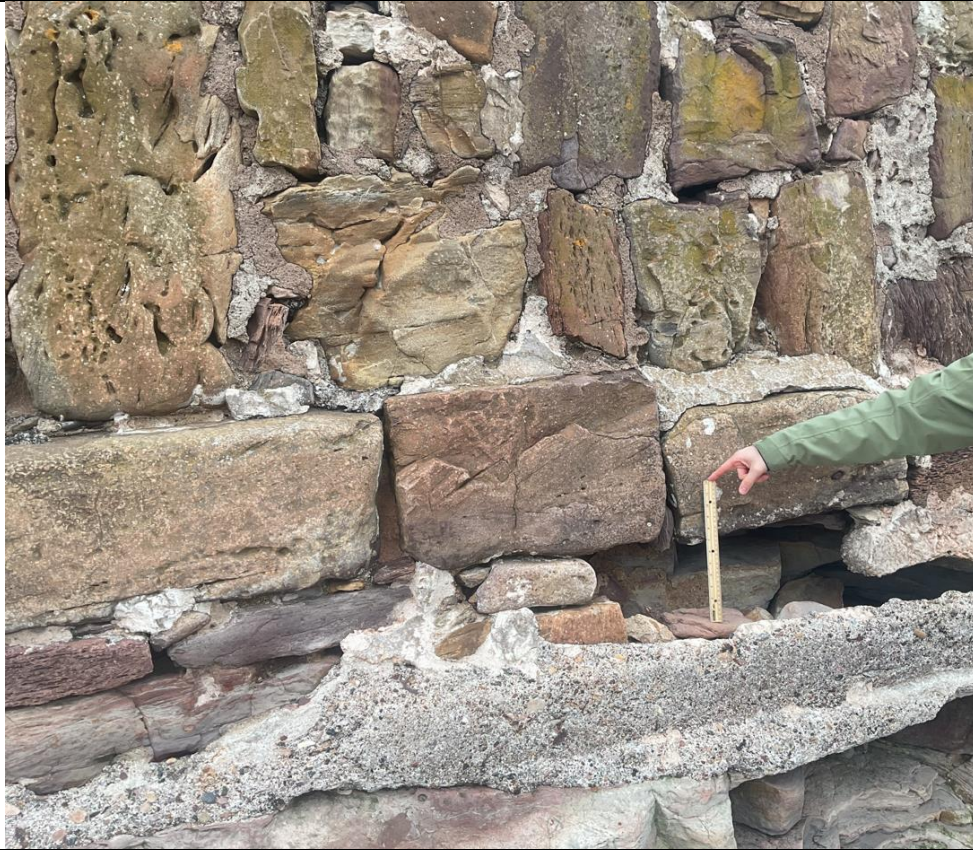
23.5m-65m	4	2.4m height, 0.6m depth	Mortar largely absent, undercutting at the base of the wall and stones missing. Where stones are missing, voids vary from 12cm to 50cm wide, and 30cm-60cm deep.	Figures 3 and 4
65m-75m	5	N/A	completely eroded, retained soils and structural members exposed	Figures 5 and 6
75m-85m	3	3.5 m tall section with intact wall 75-85m	30 cm wide void. Mortar damage, so again in areas voids where mortar should be are up to 10cm wide. Mortar better than first 65m.	Figures 7 and 8
85m-122m	5	N/A	completely eroded, retained soils and structural members exposed	Figures 9, 10, 11 and 12
122-143m	4	2m height, 0.6m depth	Complete absence of mortar between blocks. Undercutting to the wall evident.	Figures 12 and 13
143m-149m	5	N/A	completely eroded, retained soils and structural members exposed	Figure 14
149m-170m	1	1.5m height 0.5m depth	Signs of construction of a newer stretch of wall. No blocks absent and mortar present across the length.	Figures 15 and 16

*Figure 3- Undercutting of concrete foundations between ch23.5-c65.*

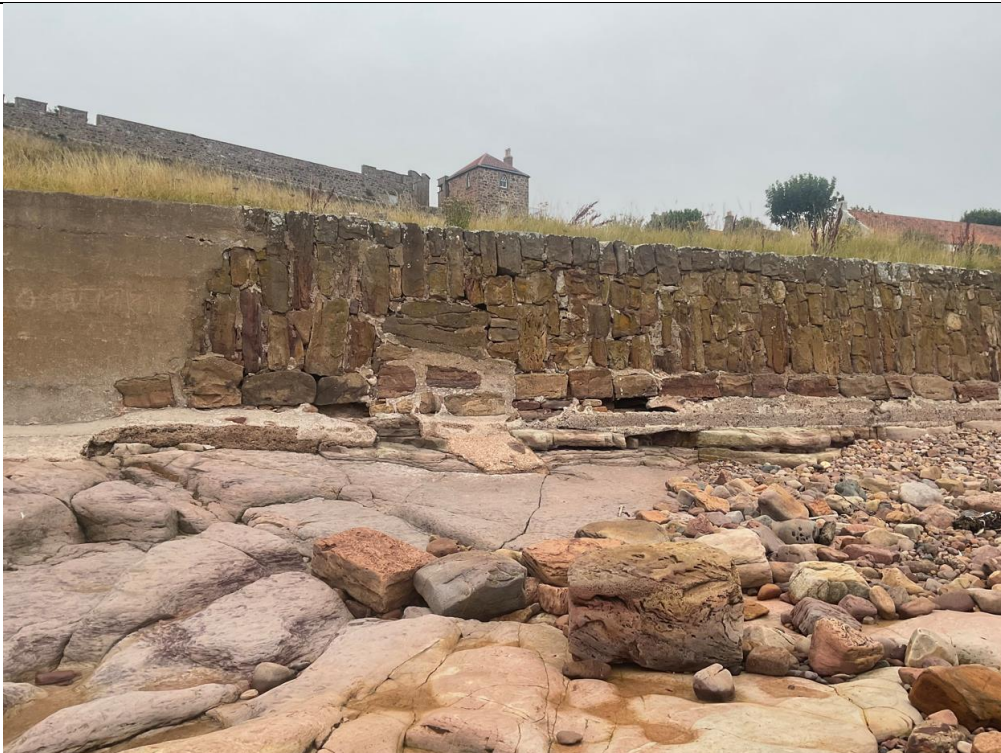
*Figure 4- General condition between ch23.5-ch65. Mortar erosion and significant undercutting to the concrete foundations.*

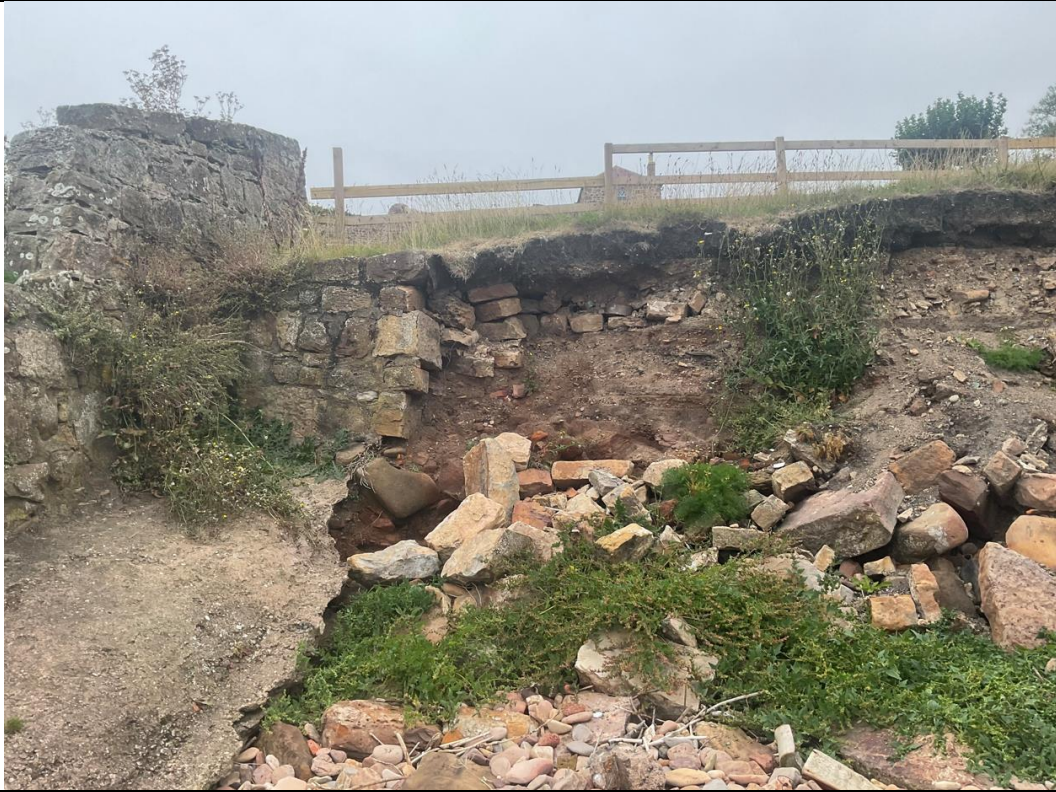
*Figure 5- Collapse of the coastal wall taken at approximately ch65.*

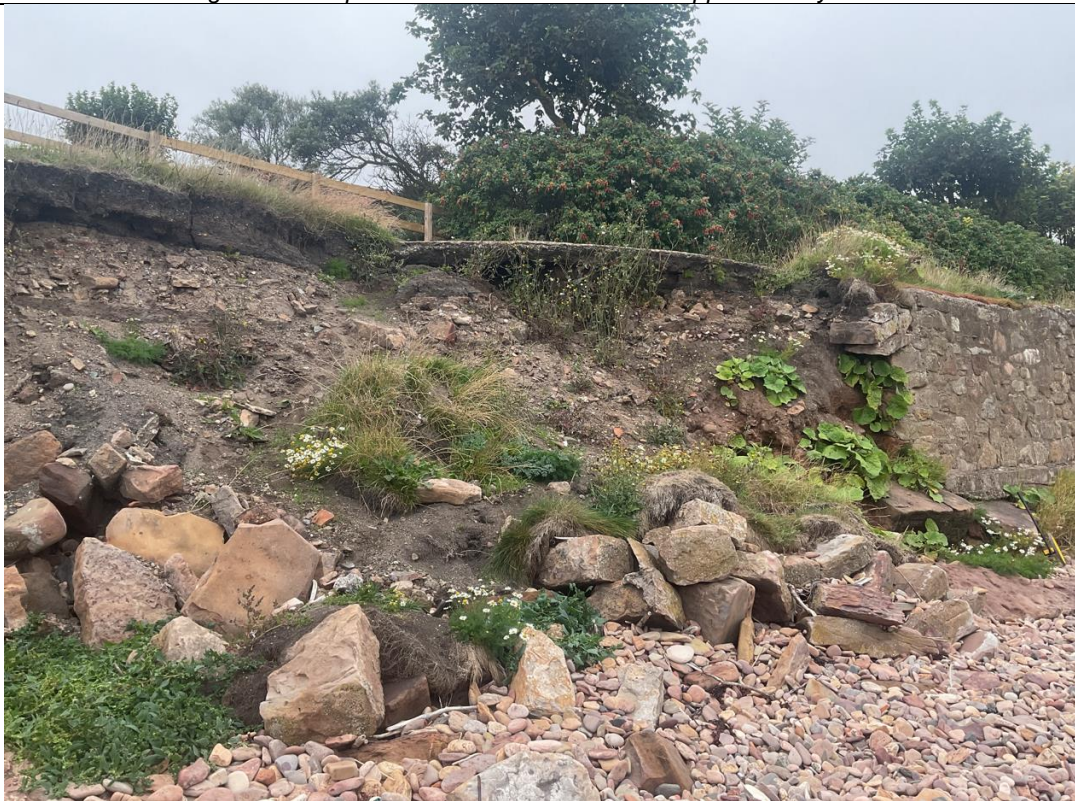
*Figure 6- Remainder of the collapsed section from approximately ch65-ch75.*

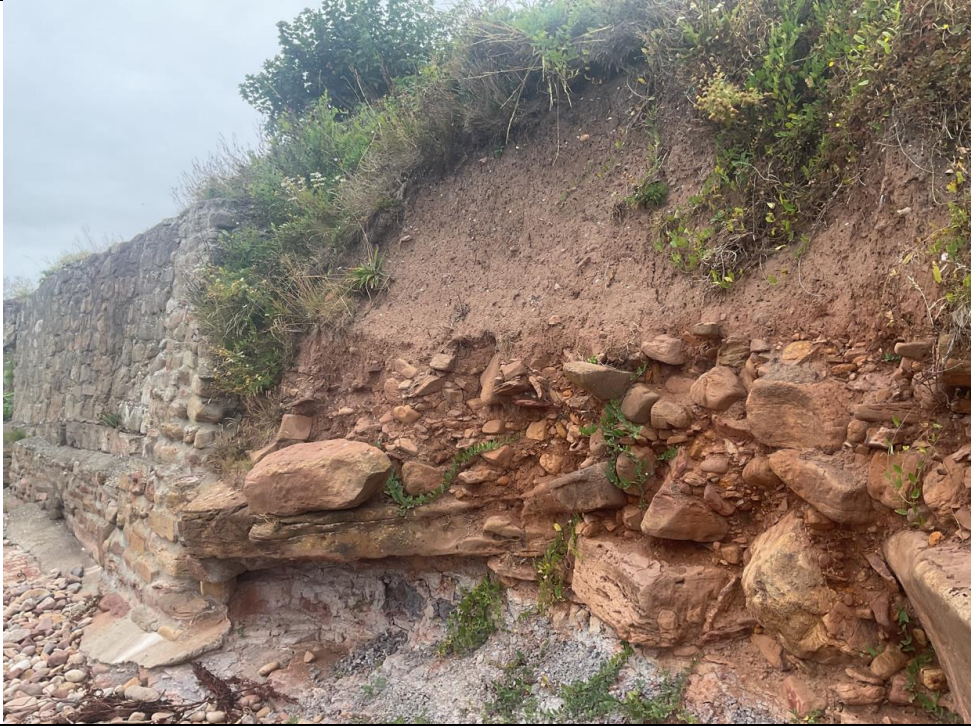
*Figure 7- Section of wall standing between ch75-ch85. Photo taken from the north side of the damaged section looking south.*

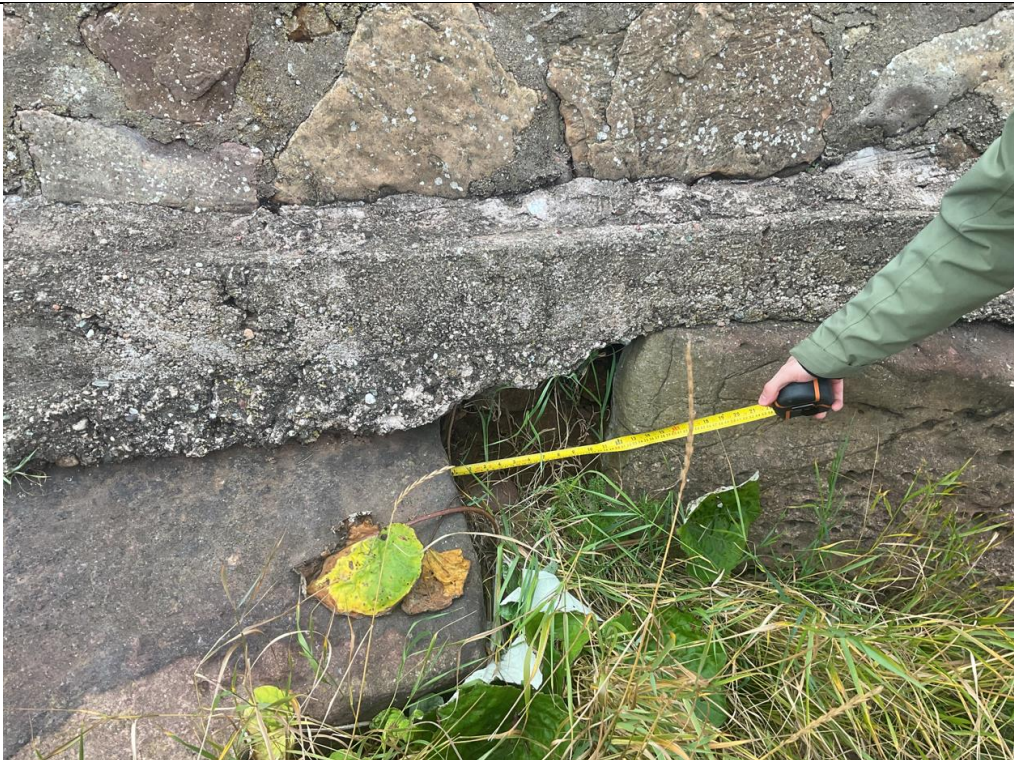
*Figure 8- Undercutting to the concrete foundations of the wall located between ch75-ch85.*

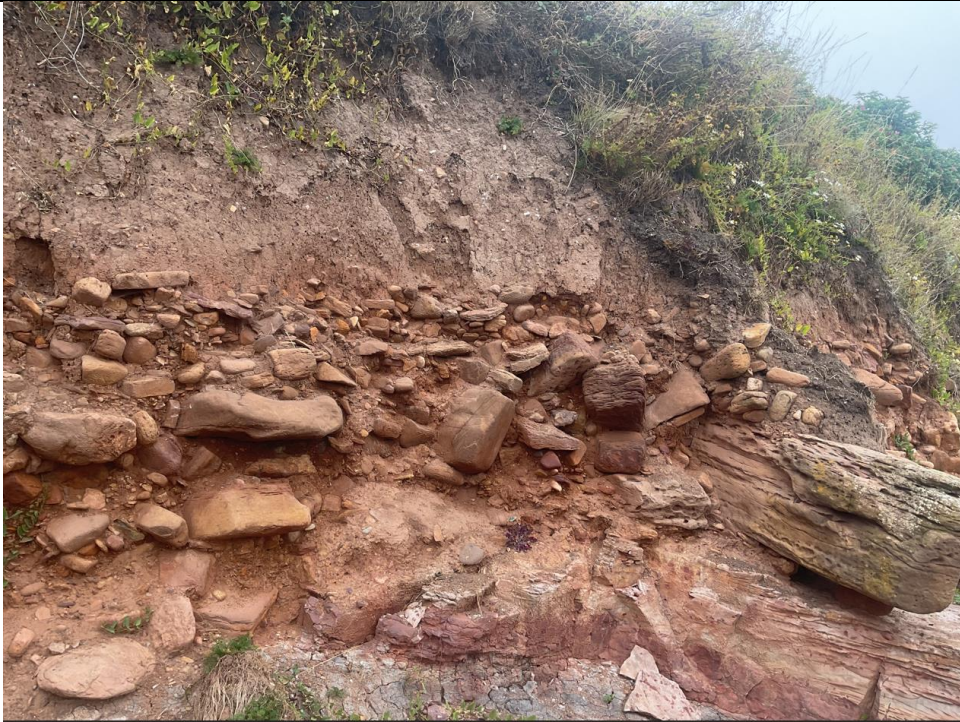
*Figure 9- Photo taken between ch85-ch122, wall completely eroded and structural members exposed.*

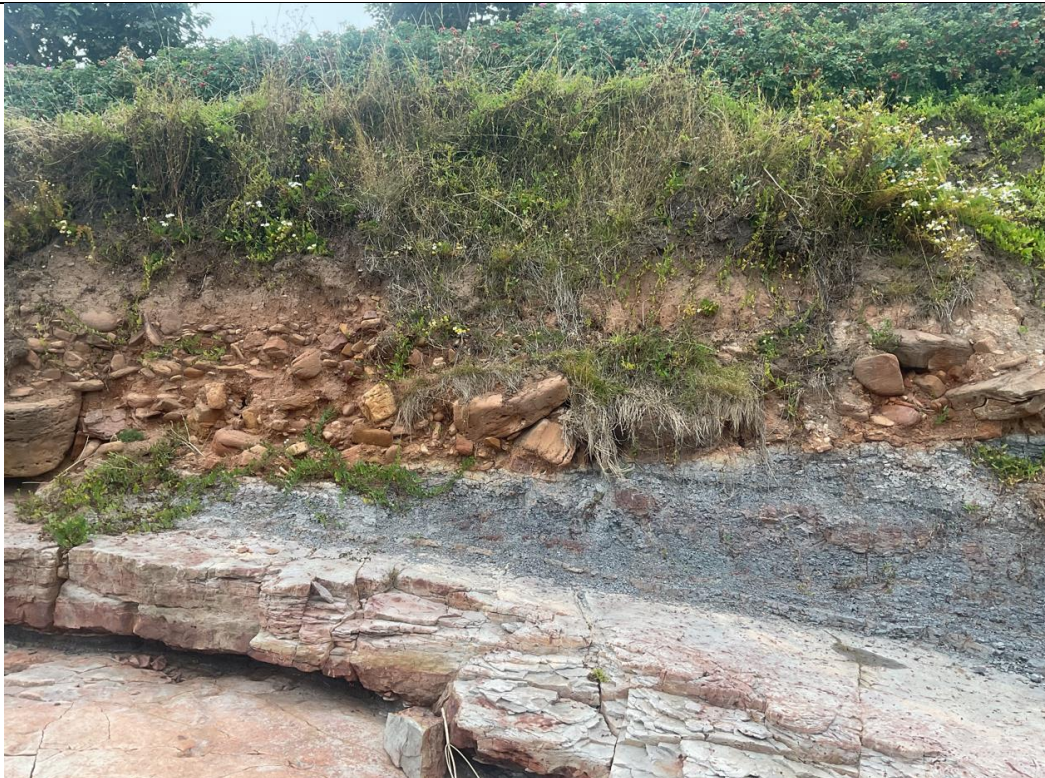
*Figure 10- Photo taken between ch85-ch122, wall completely eroded, large mudstone beds visible behind where the previous structure stood.*

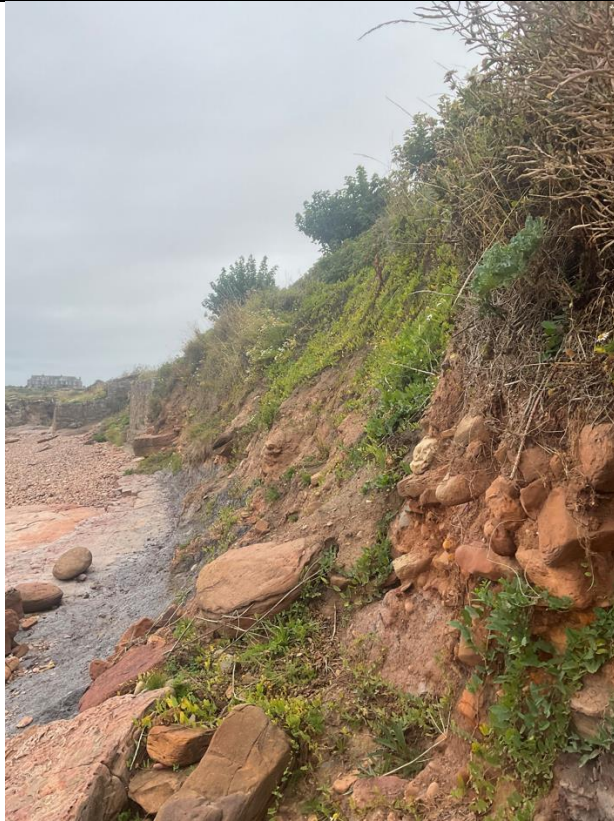
*Figure 11- Photo taken between ch85-ch122, wall completely eroded, large mudstone beds visible behind where the previous structure stood.*

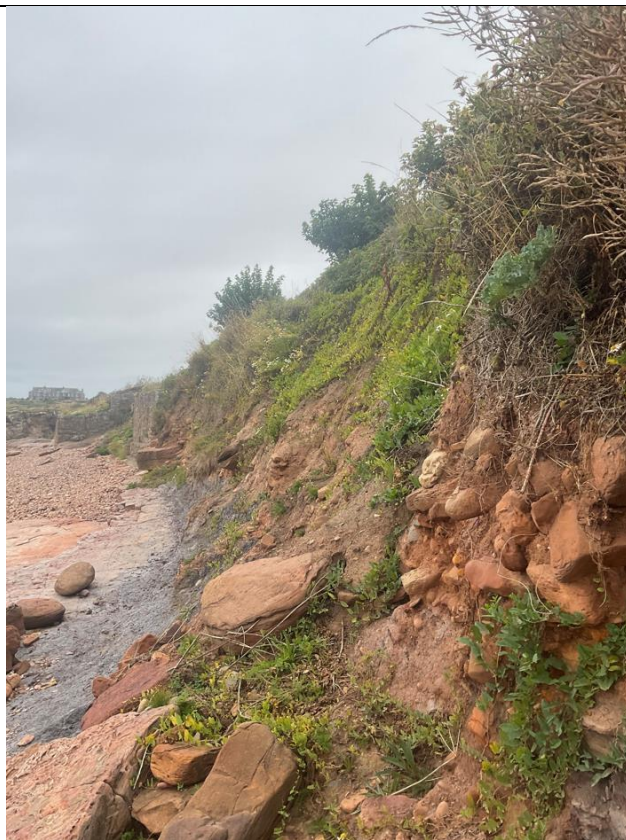
*Figure 12- Photo taken between ch85-ch122 facing south, wall completely eroded, near vertical slope.*

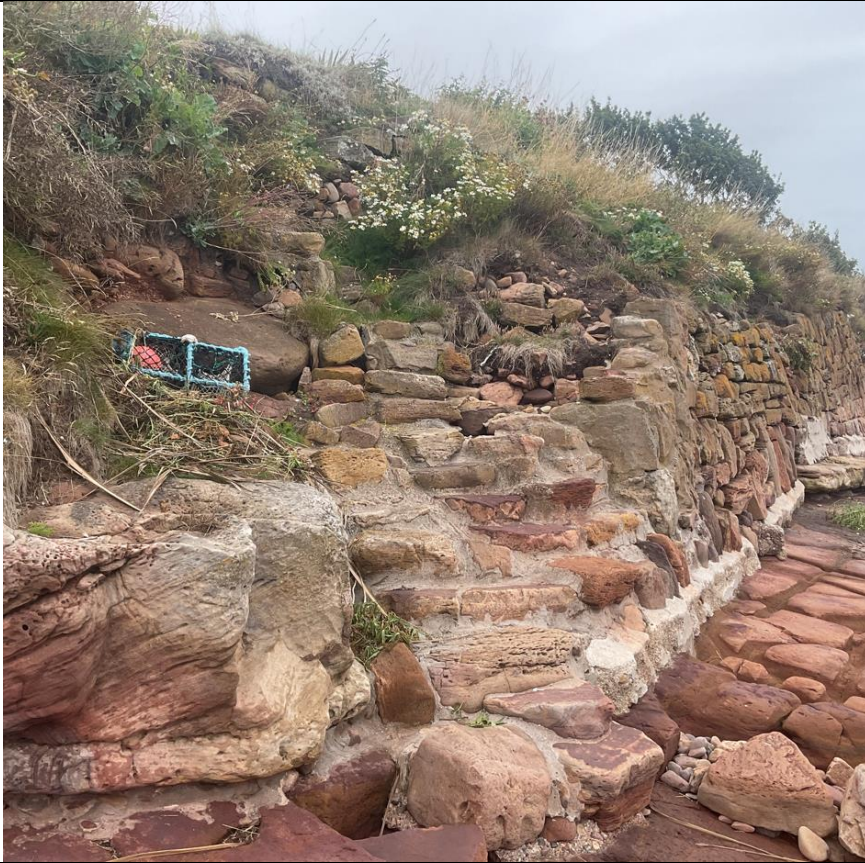
*Figure 13- Photo taken between ch122-ch143, wall gradually reappears from the completely eroded state.*

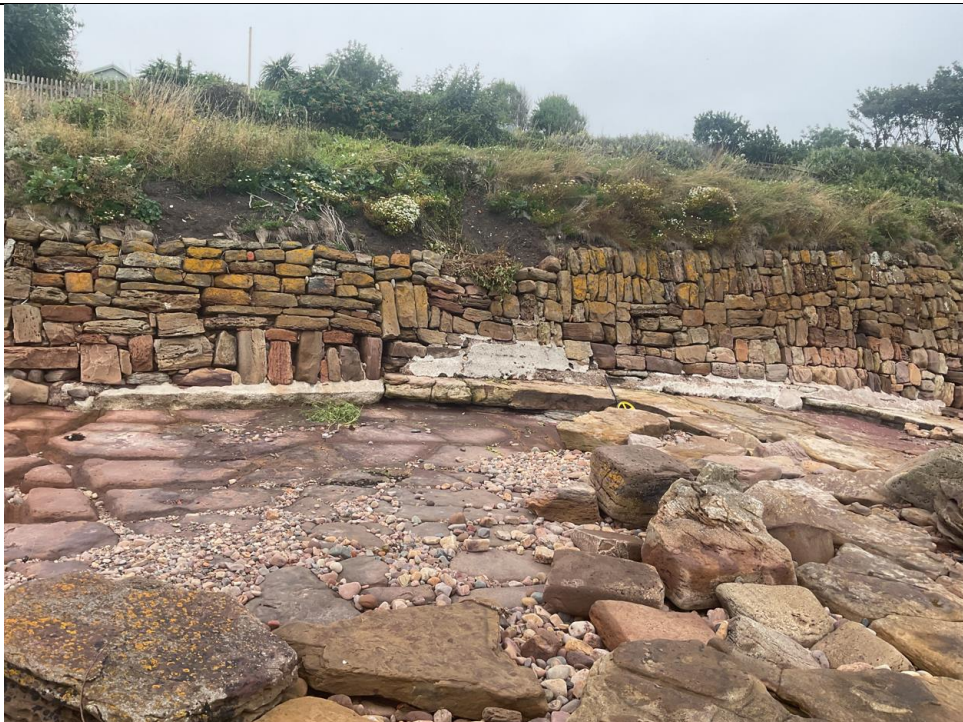
*Figure 14- Frontal view between ch122-ch143, complete absence of mortar concrete foundations see, okay. Where the wall has been founded on a large sandstone bed there has been undercutting.*

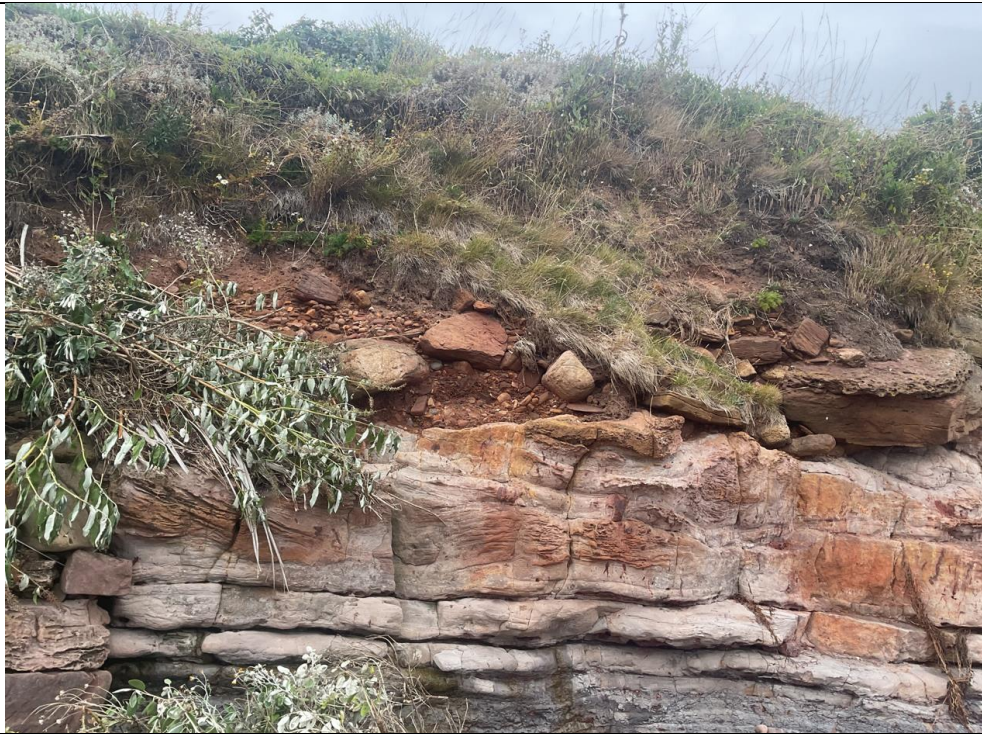
*Figure 15- Between ch143-ch149, the wall has been completely eroded and structural members exposed.*

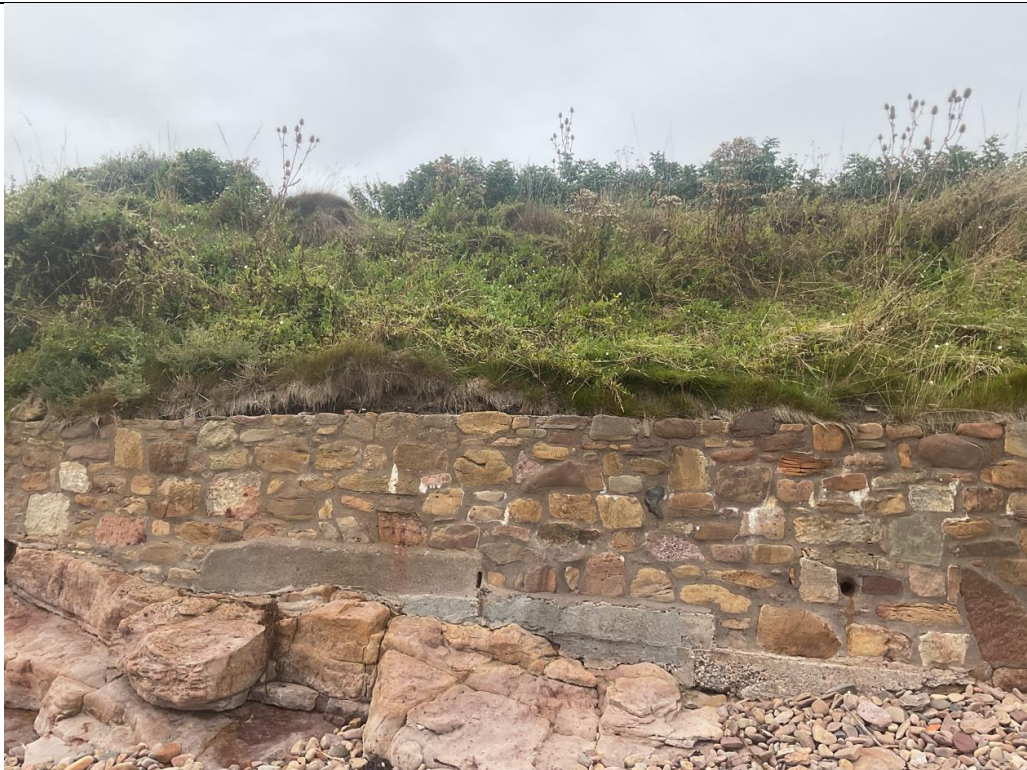
*Figure 16- Between ch149-170 a newer section of wall has been Constructed.*

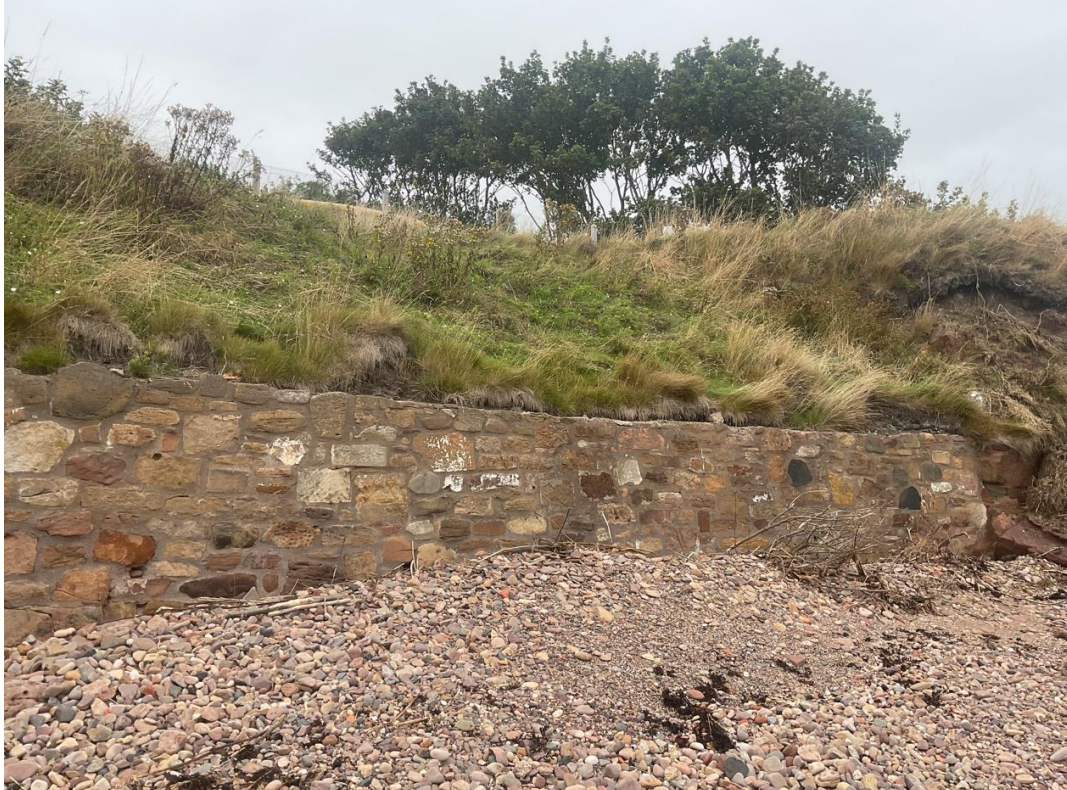
*Figure 17- Between ch149-170 a newer section of wall has been constructed.*

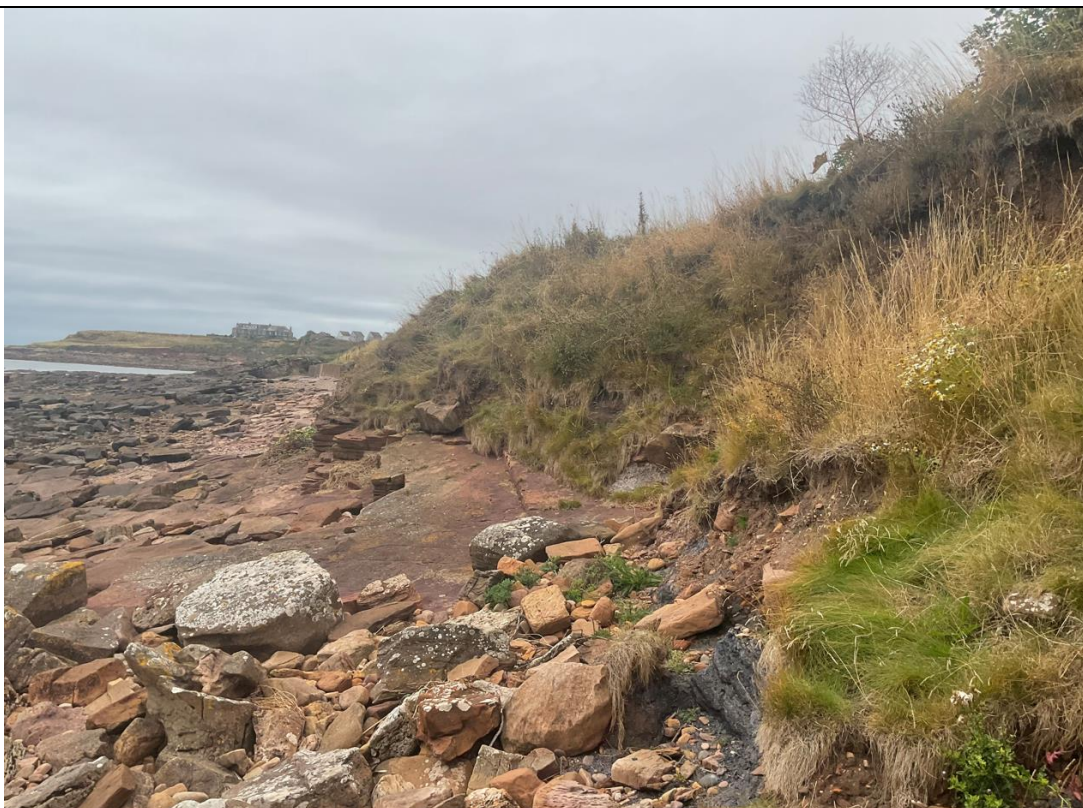
170m-239m	5	N/A	Completely eroded, retained soils and structural members exposed.	Figures 17, 18 and 19
239-276m	3	2.2m-2.3m height, X.X depth	Small footbridge connecting two sections of wall. On the north side under the foot bridge there is a void approximately 1m long and 30cm wide. The mortar is present between stones.	Figures 20 and 21
276-297m	4	2.9m height, 1m depth	General undercutting to the structure. Larger stone at the base of the wall seems displaced. Voids vary between 0.9-1.5m widths. Mortar damage minimal.	Figure 22
297-347m	4	Wall height 3.3m, 0.5m-1.2m deep.	General mortar damage across the length. Voids located at the base of the wall across the length of the section. Voids are between 10cm-0.5m wide. The wider voids are a result of missing stones/blocks.	Figures 23, 24 and 25
347m-396m	4	2.7m height, 0.5-0.9m deep.	General mortar deterioration. Undercutting to the base of the wall. Ten large voids along the length, ranging between 0.5-1.5m wide.	Figures 26, 27, 28, 29 and 30.

*Figure 18- Between ch170-ch239, the wall has been completely eroded. Photo taking standing from the north looking south.*

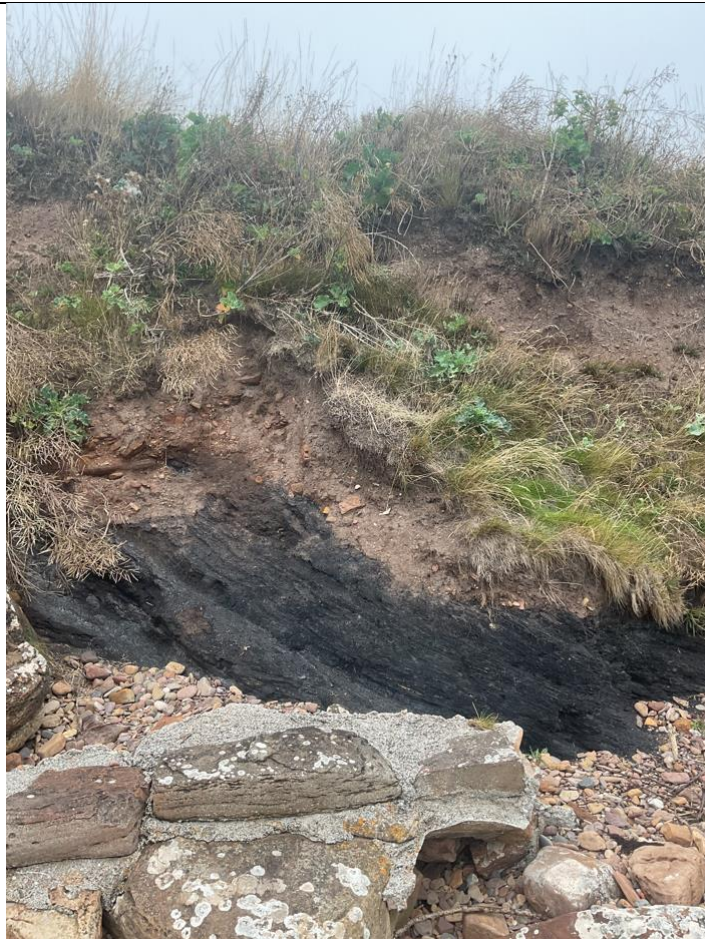
*Figure 19- Between ch170-ch239, the wall has been completely eroded. Dark rock exposed, possible coal.*

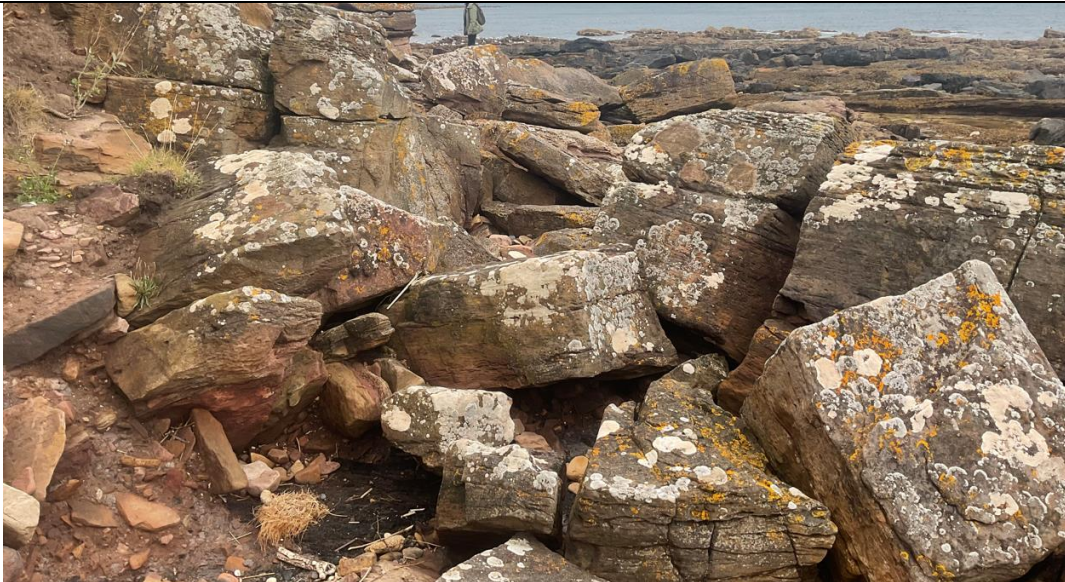
*Figure 20- Photo taken between ch170-ch239, looking north, up the coast.*

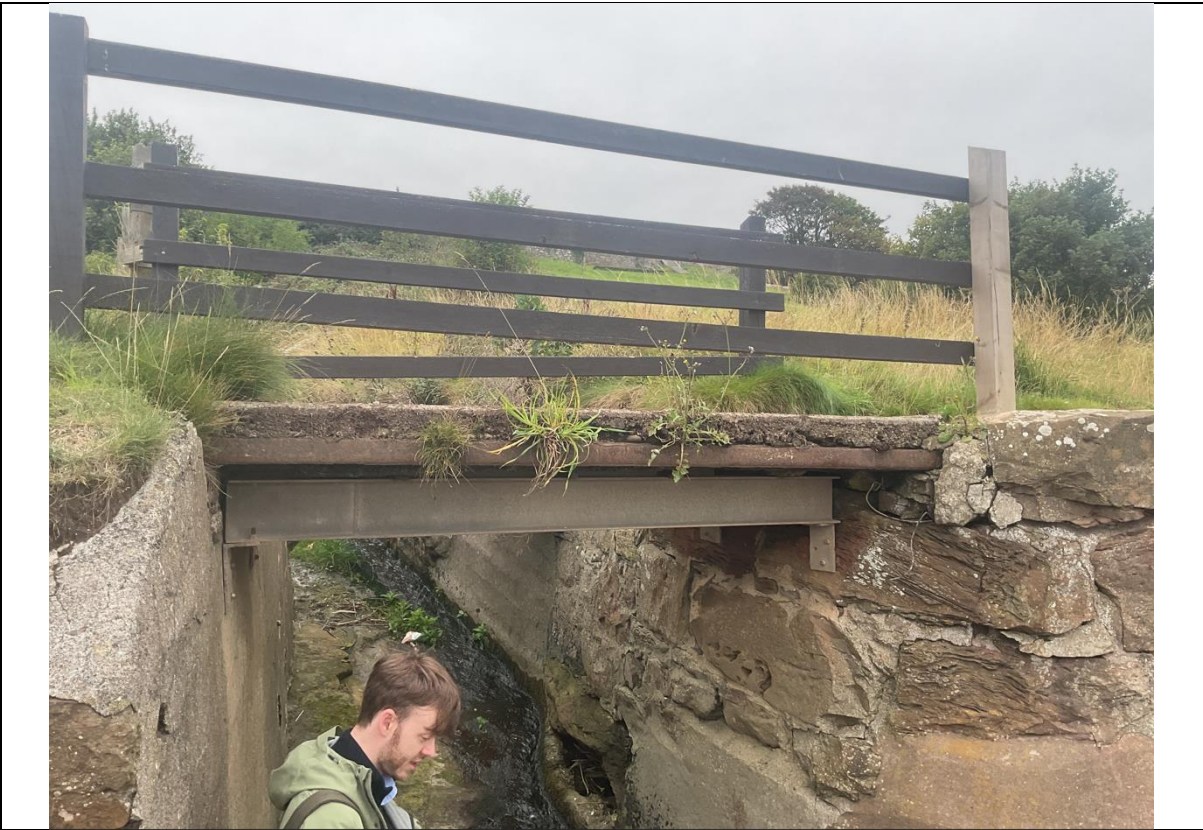
Figure 21- Footbridge located at ch239. Void visible on the northern side of the coastal wall, under the bridge.

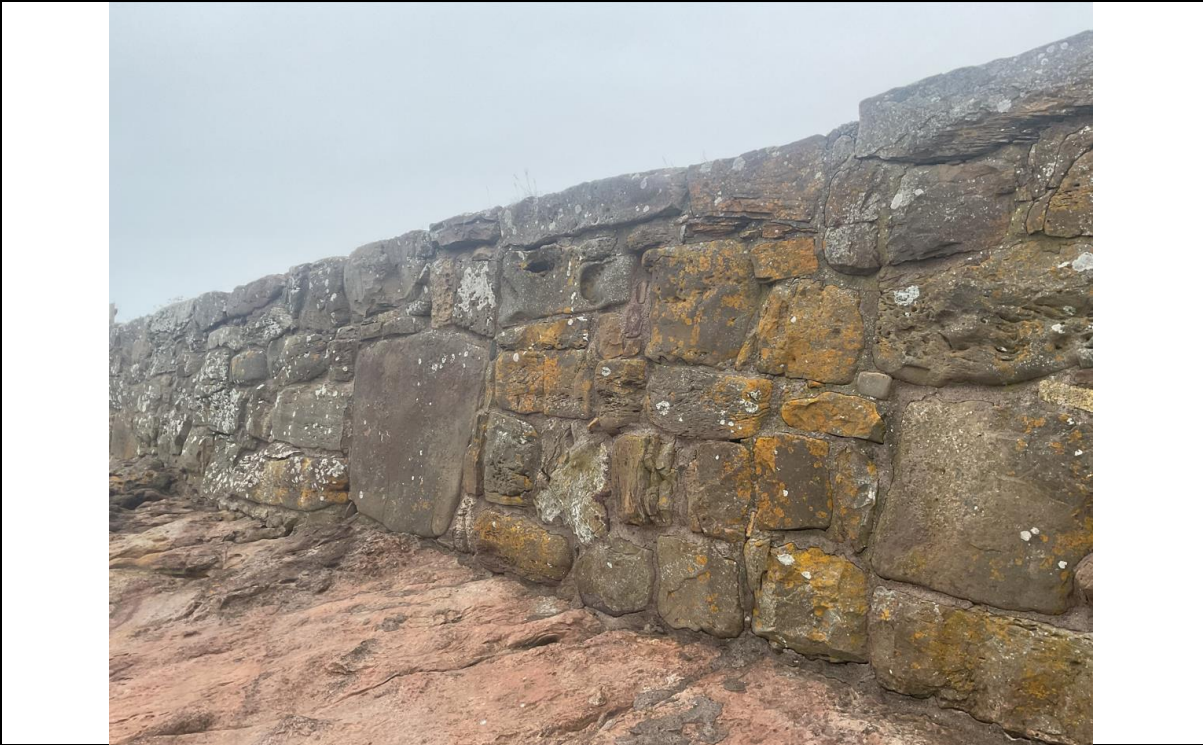
Figure 22- Generally good wall condition between ch239 and ch276.

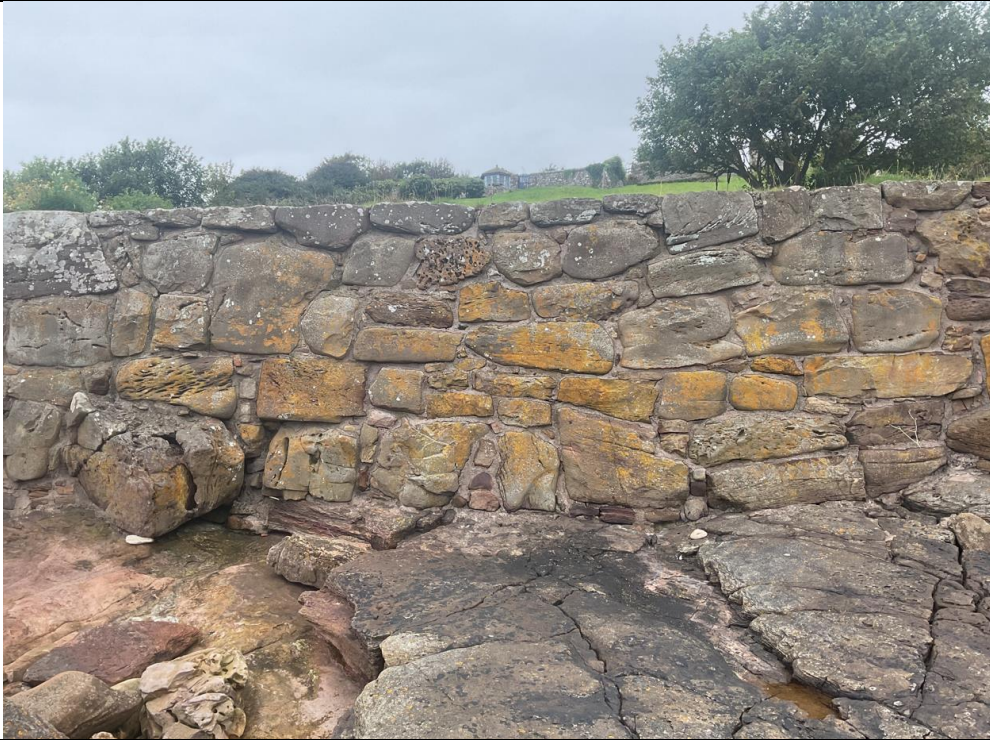
*Figure 23- Generally wall condition is good between ch276-297. Larger stone at the base of the wall possibly displaced. Some undercutting to the structure at the base.*

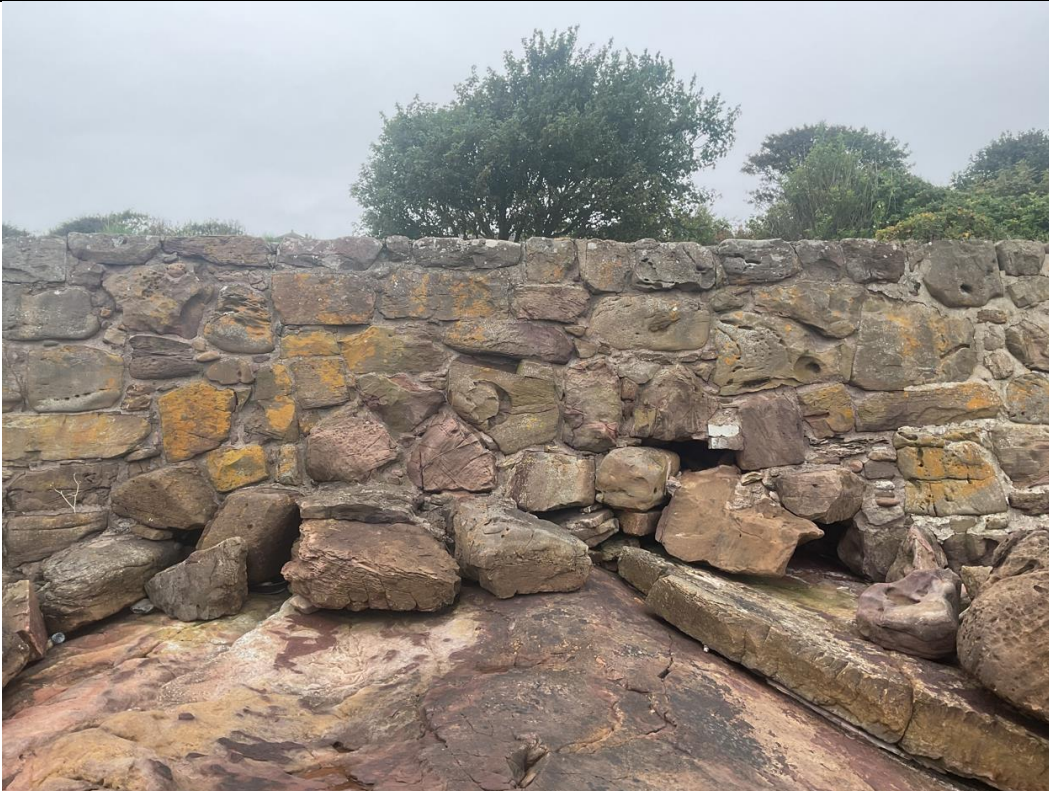
*Figure 24- Between ch297 and ch347, mortar and stone condition generally okay. Some stones at the base of the wall possible displaced. Where there is displacement there are voids behind.*

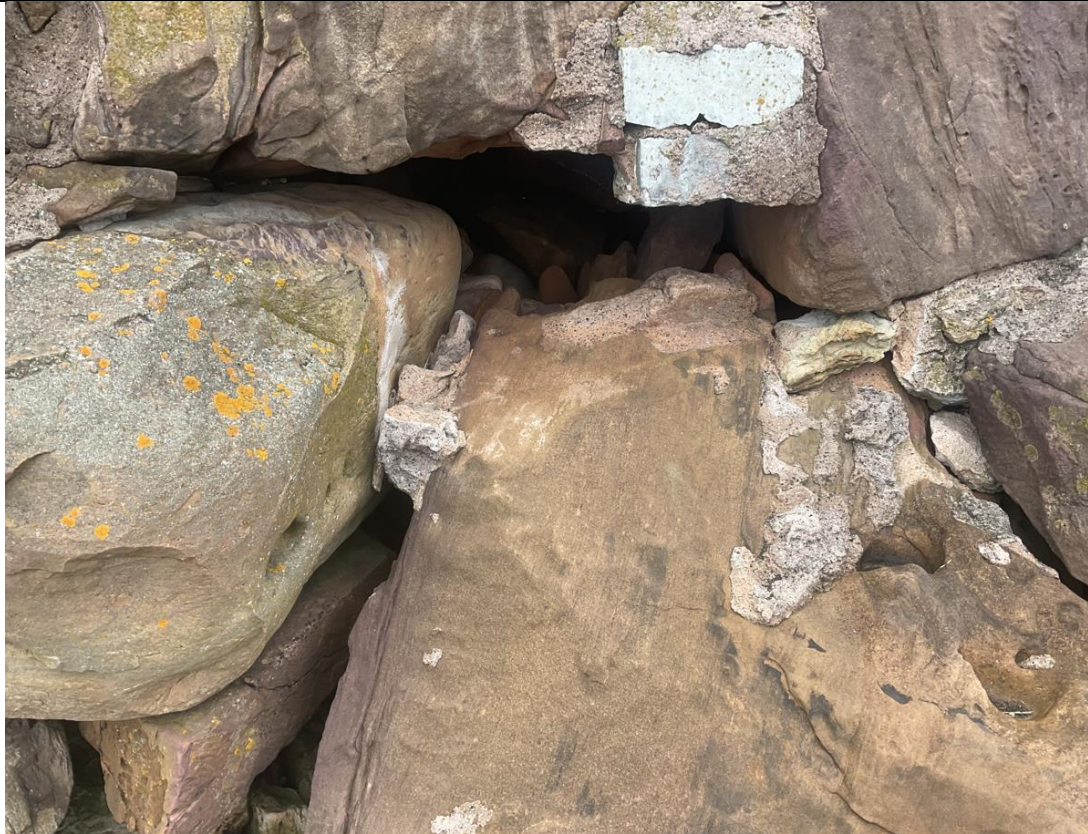
*Figure 25- Voids located behind the displaced stones in figure 23.*

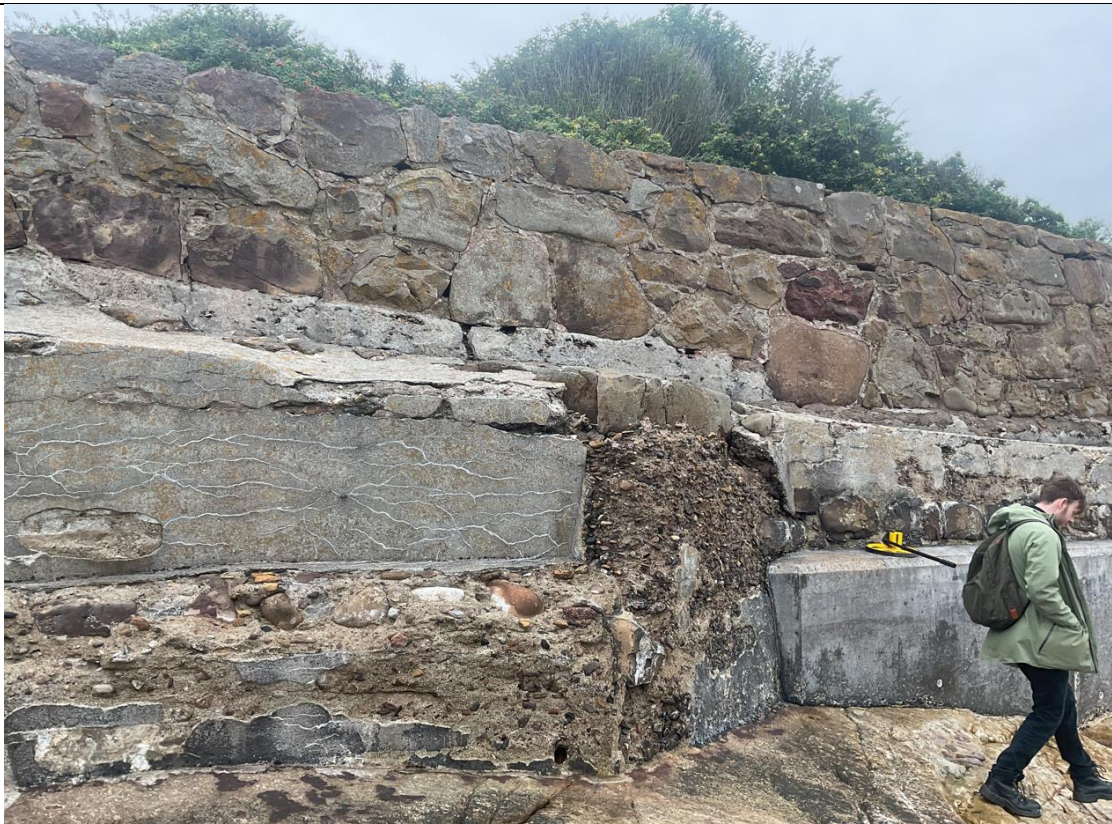
*Figure 26- Generalised wall condition for between ch297-ch347. Concrete foundations are much thicker.*

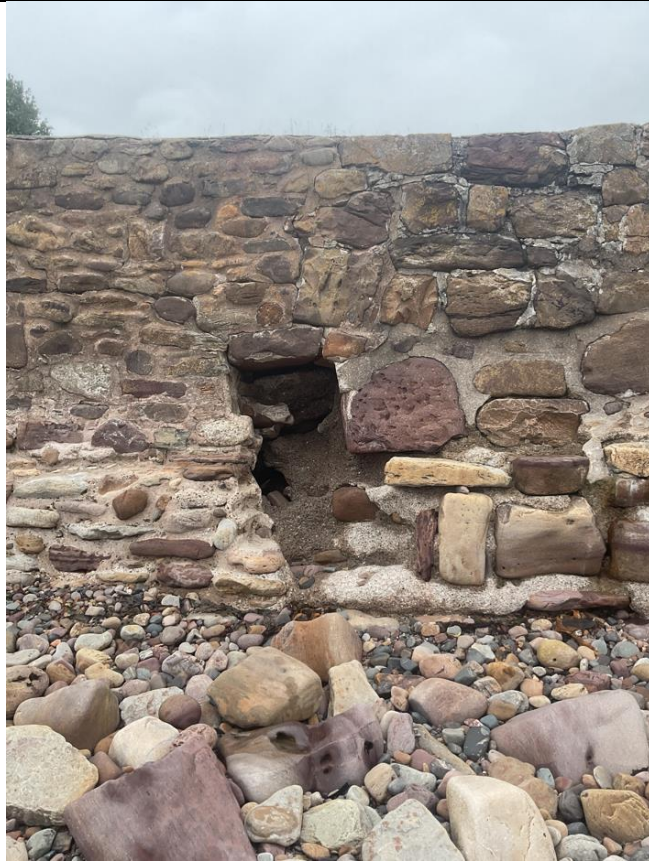
*Figure 27- Large void located between ch347-ch396.*

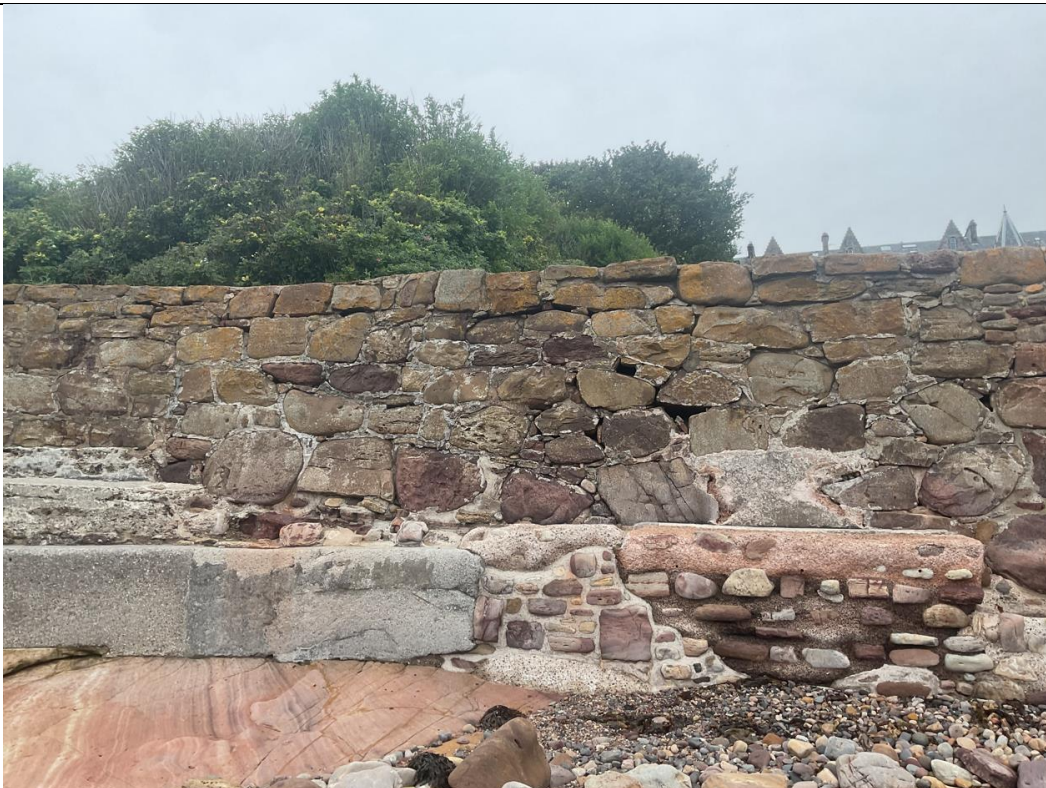
*Figure 28- General wall condition between ch347-ch396. Voids located at varying heights u the wall.*
