# Crail Coastal Path- Erosion Protection

## Inspection Survey Report

September 2024

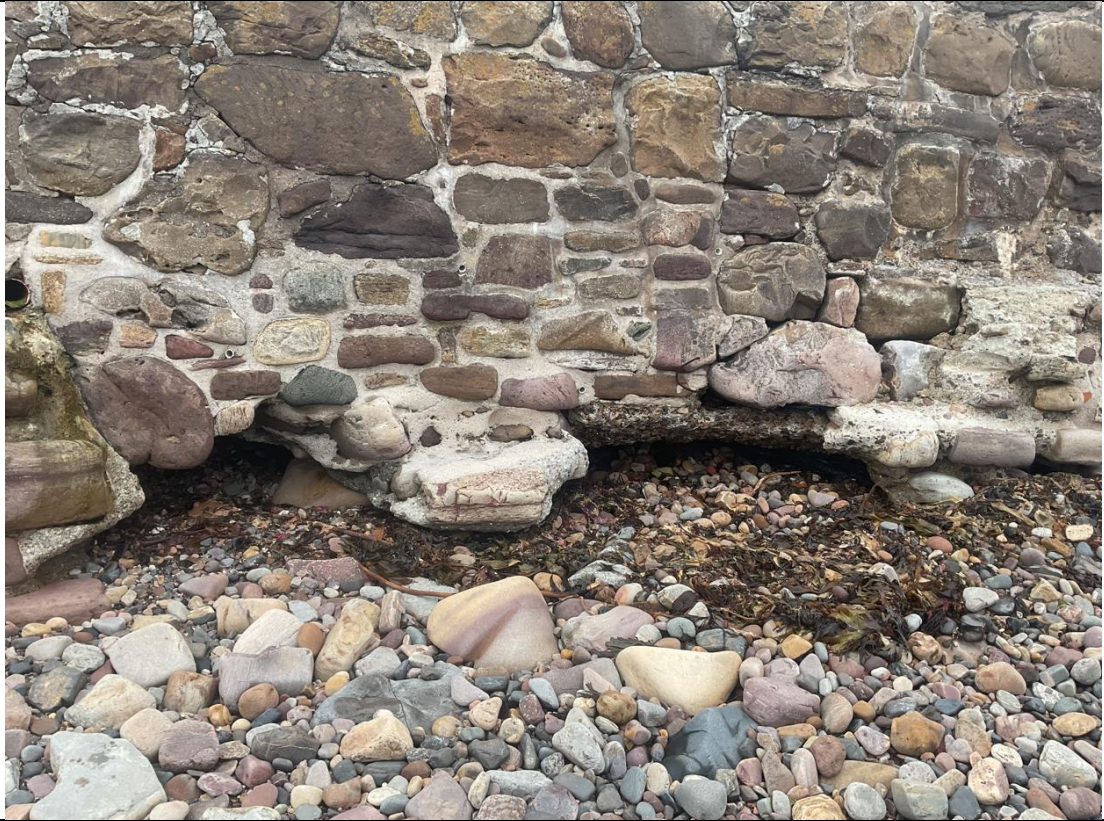
*Figure 29- Two areas of undercutting to the wall located between ch347 and ch396.*

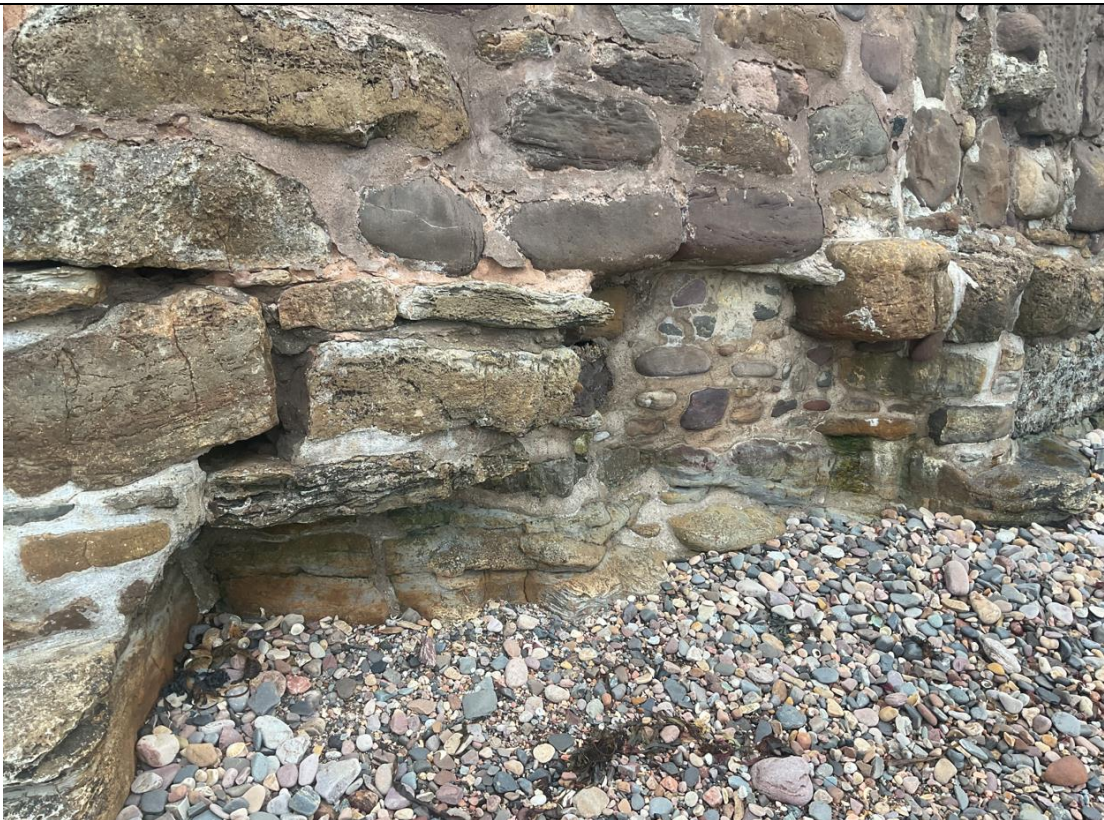
*Figure 30- Further erosional damage between ch347-ch396.*

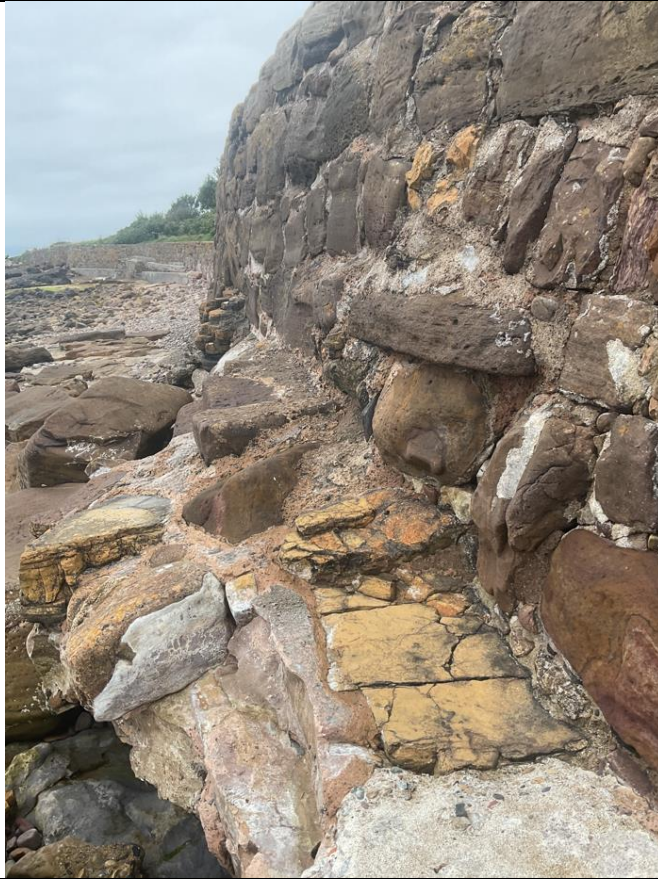
<b>Wall Section</b>	<b>Degree of damage</b>	<b>Wall height and depth</b>	<b>Observations</b>	<b>Figures</b>
396-445m	4	2.7m-3.3m height, depth up to 1.2m	General continuation of wall damage. Mortar and stones appear weathered. Three large voids at the base of the wall 1m long and 0.2-1.3m wide.	Figures 31 and 32

*Figure 31- Significant displacement of stones at the base of the wall located at ch393.*

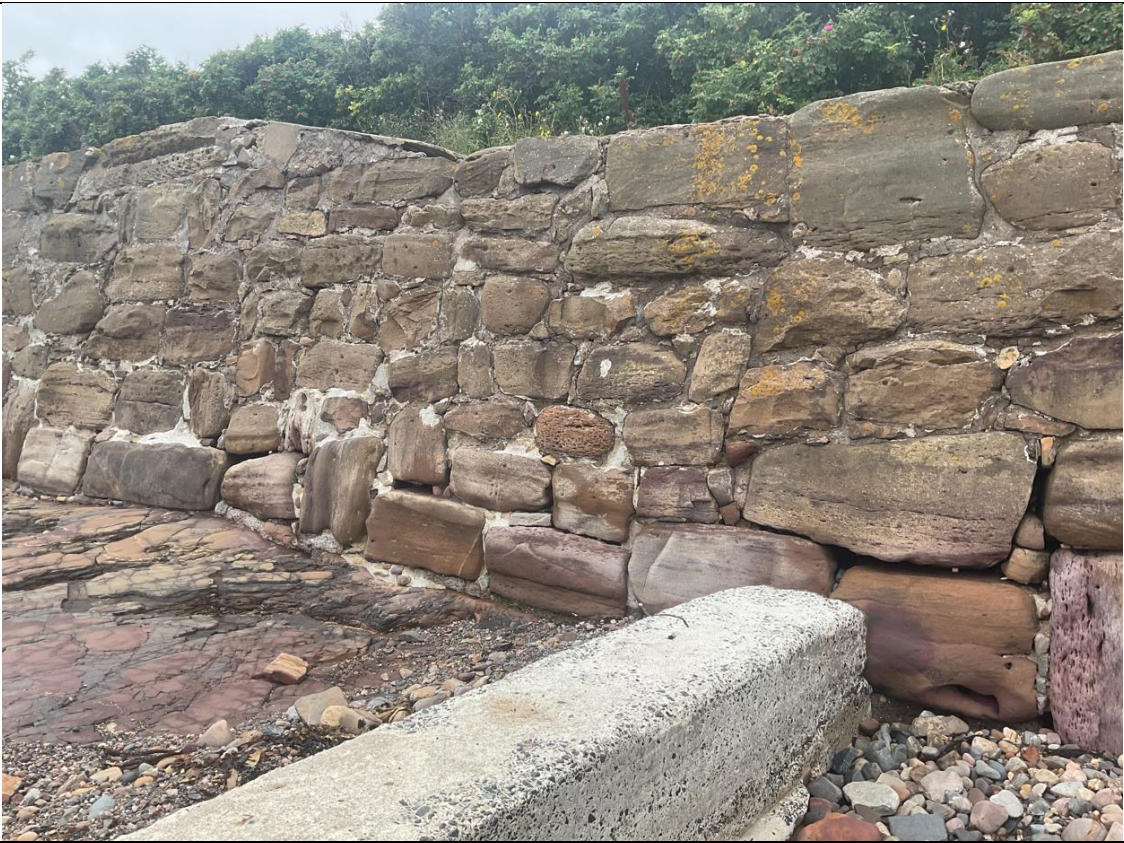
*Figure 32- General wall condition approximately between ch396-ch458.*

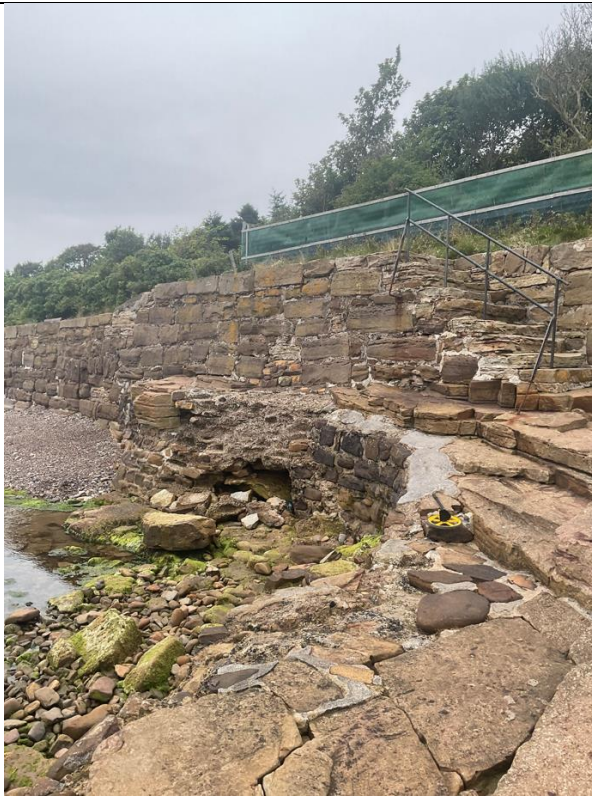
*Figure 33- General wall condition at ch458.*

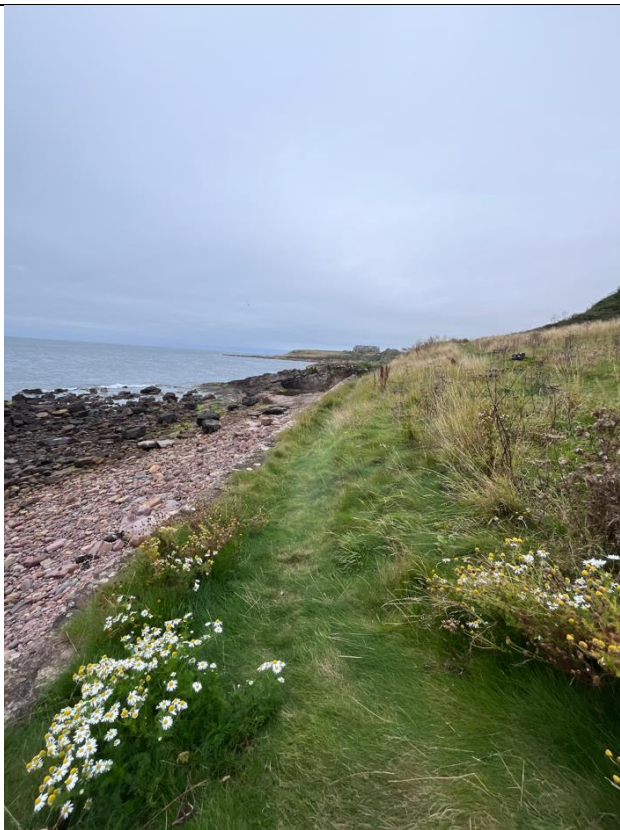
*Figure 34- Between ch000-ch65 there is no path/surface cover.*

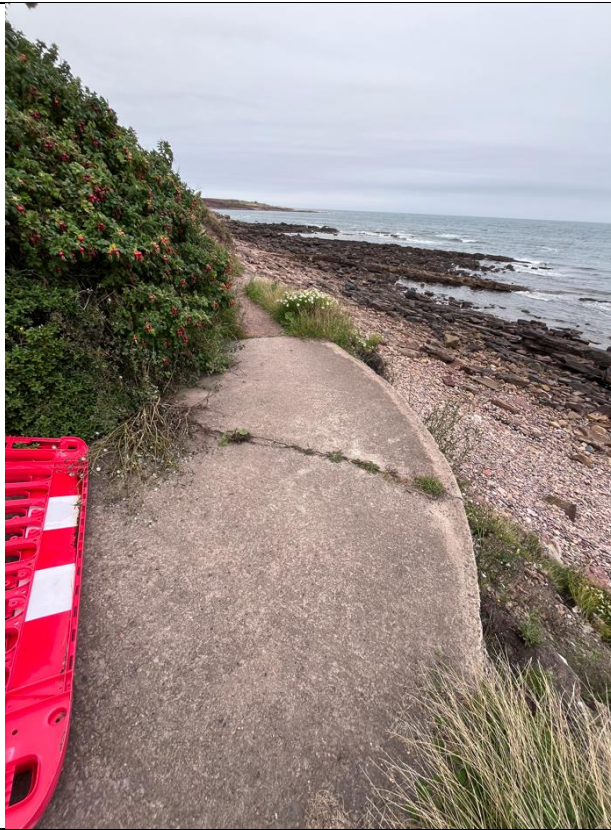
*Figure 35- Short 3 metre section between ch65-ch68 of path which is in an okay condition.*

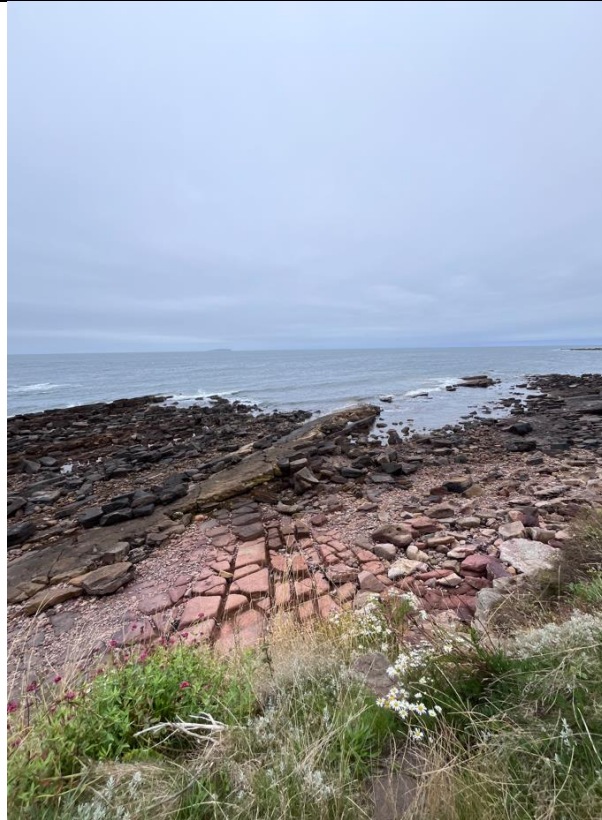
The areas where the wall has collapsed coincide with lower lying areas of ground on the foreshore area (Figures 35, 36 and 37). The lower areas of ground are surrounded by higher beds of sandstone bedrock. The effect of this topography appears to have created channels where wave energy is locally focussed on damaged sections of the wall. The result is greater rates of erosion and a tendency towards failure.

*Figure 36- Foreshore area in front of the stretch of wall/coastal path which is largely absent (ch65-ch236).*

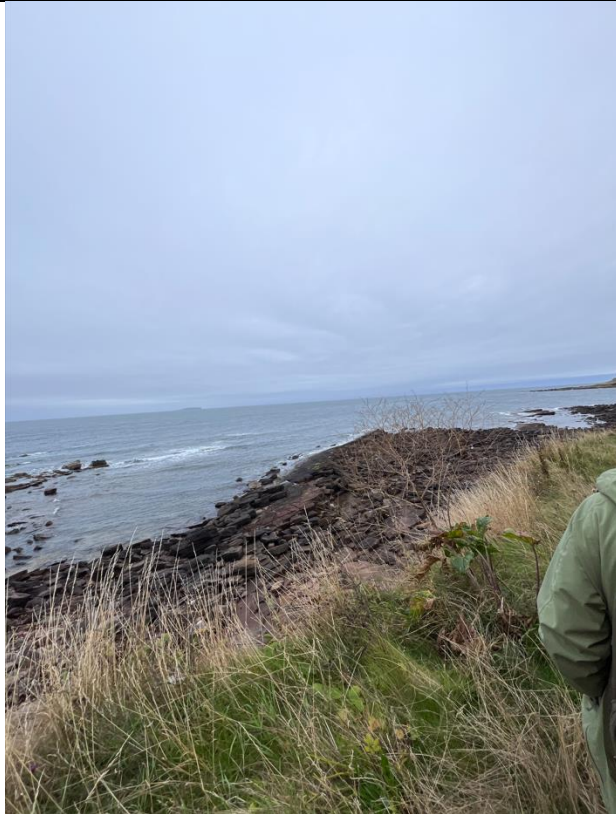
*Figure 37 Foreshore area in front of the stretch of wall/coastal path which is largely absent (ch65-ch236).*

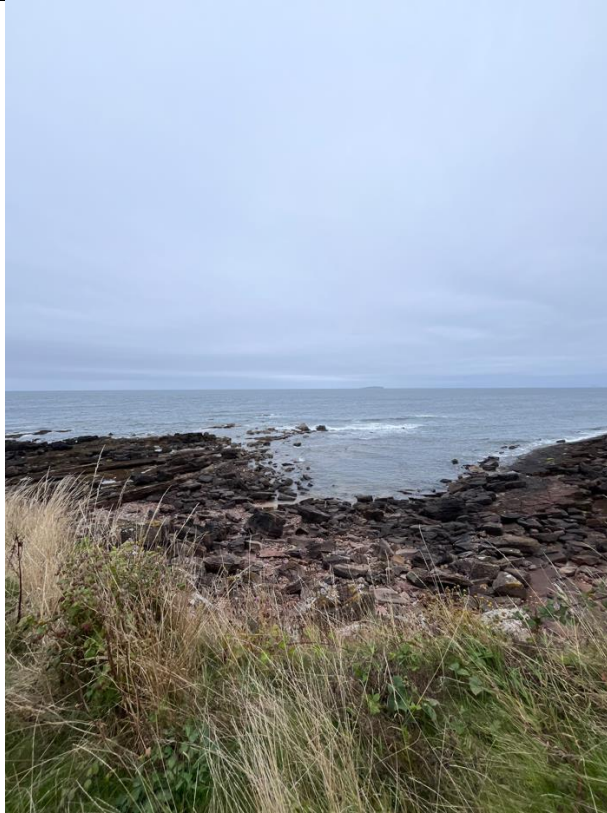
*Figure 38- Foreshore area in front of the stretch of wall/coastal path which is largely absent (ch65-ch236).*

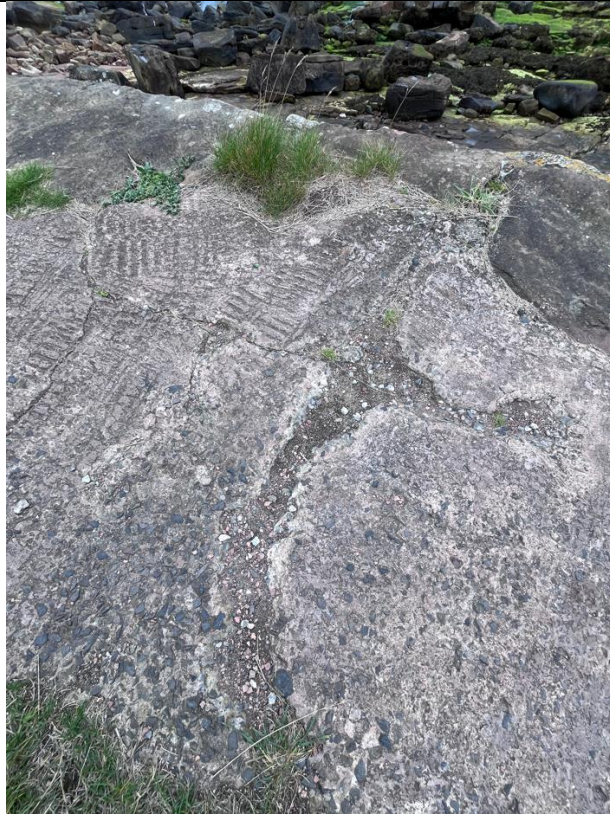
*Figure 39- General condition of the path between ch236-ch272. Cracking appears to be over 7.5cm wide, although not altered the structure of the path.*

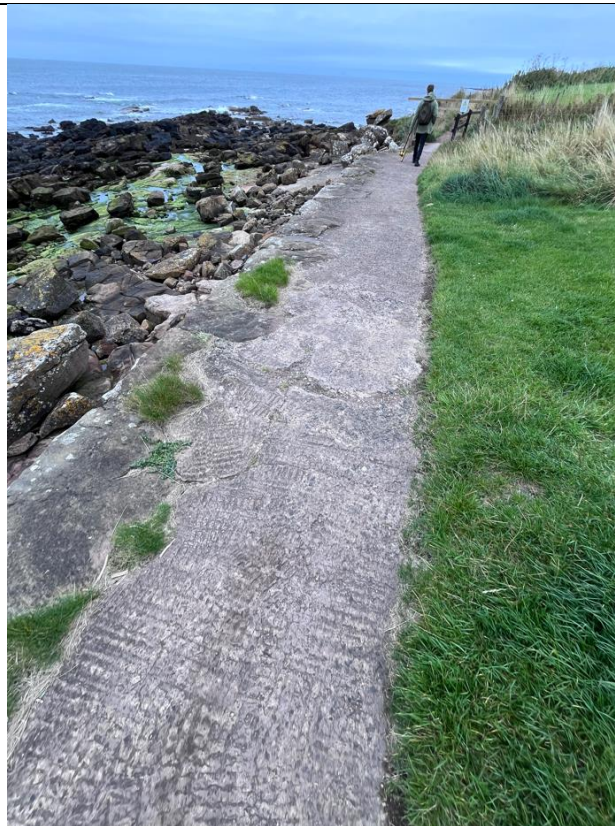
*Figure 40- General condition of the path surface between ch236-272.*

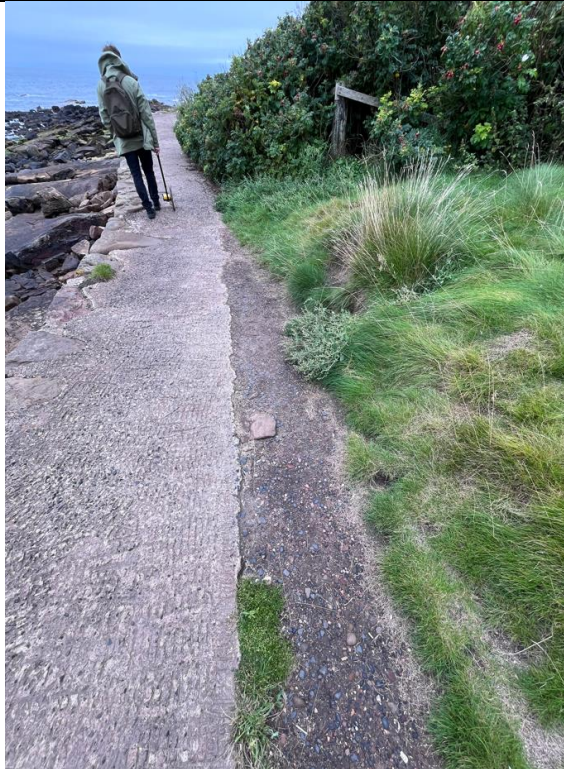
*Figure 41- Subgrade materials exposed at the surface of the path between ch272-ch284.*

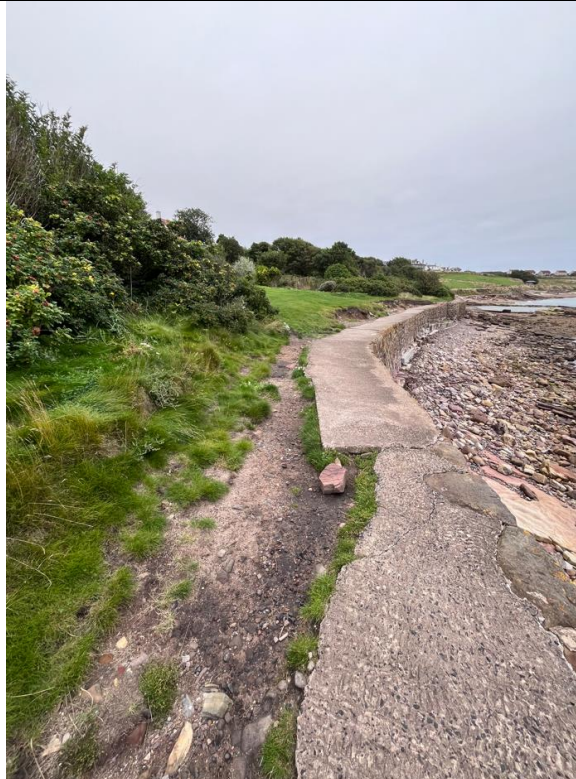
*Figure 42- Subgrade materials exposed at the western surface edge, assumed to be subgrade materials. Located between ch284-ch295.*

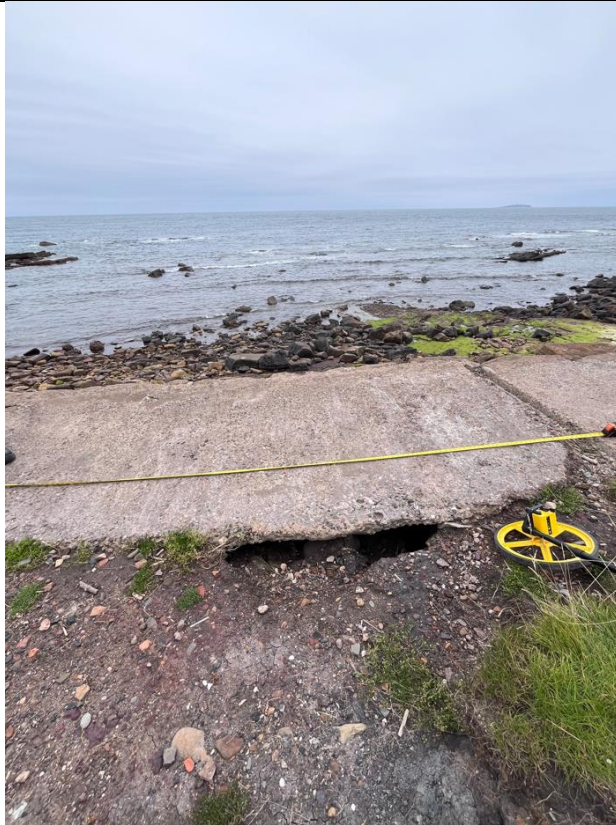
Cracking is generally present throughout the concrete surface where still present. A large depression was noted at Ch299 where the concrete surfacing was missing, leaving the underlying granular subgrade exposed.

*Figure 43- Large void at the western edge of the path located at approximately ch295.*

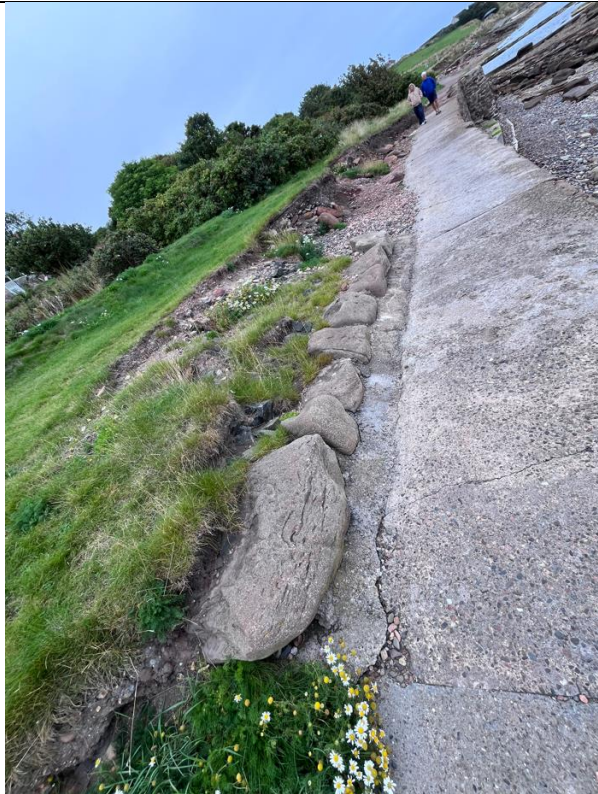
Between 272m and 295m there is a large section of raised eroded sediment to the west of the path. It is assumed the erosional damage caused is due to the overtopping of waves.

*Figure 44- Erosional damage to land west of the path edge, potentially overtopping waves between ch284-ch295).*

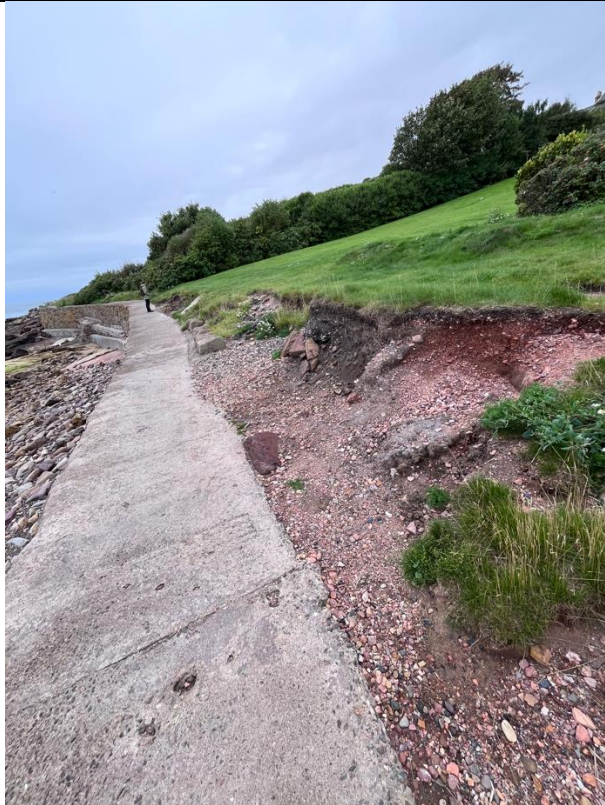
*Figure 45- Erosional damage to land west of the path edge, potentially overtopping waves between ch284-ch295).*

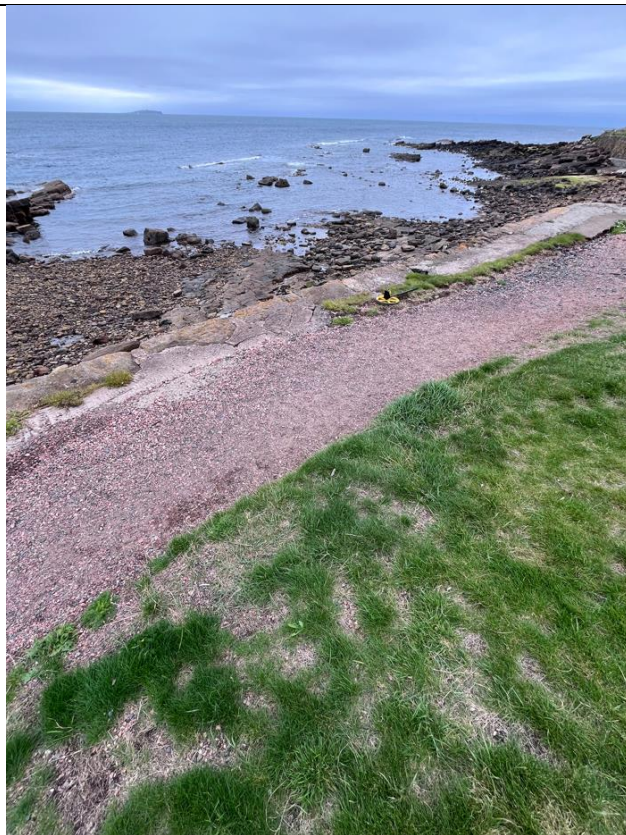
*Figure 46- Subgrade material coverage, between ch295-ch341.*

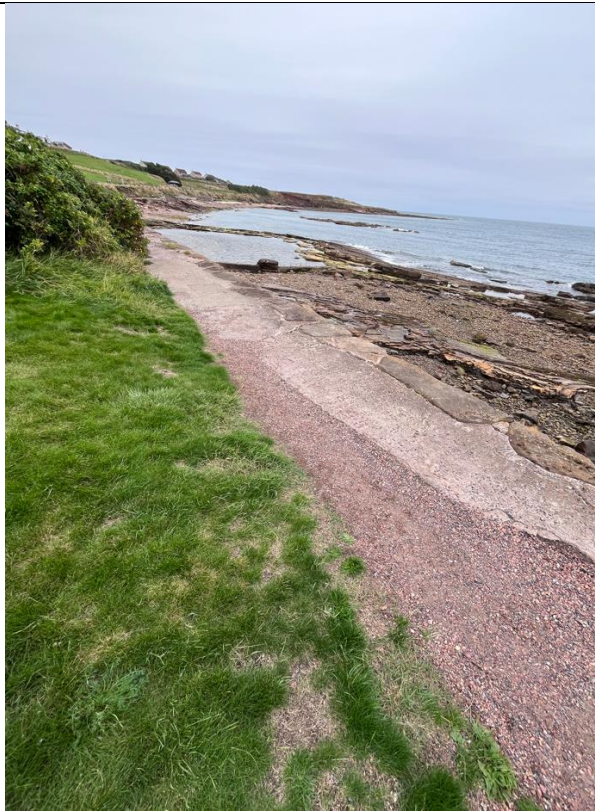
*Figure 47- Subgrade material coverage, between ch341-ch349.*

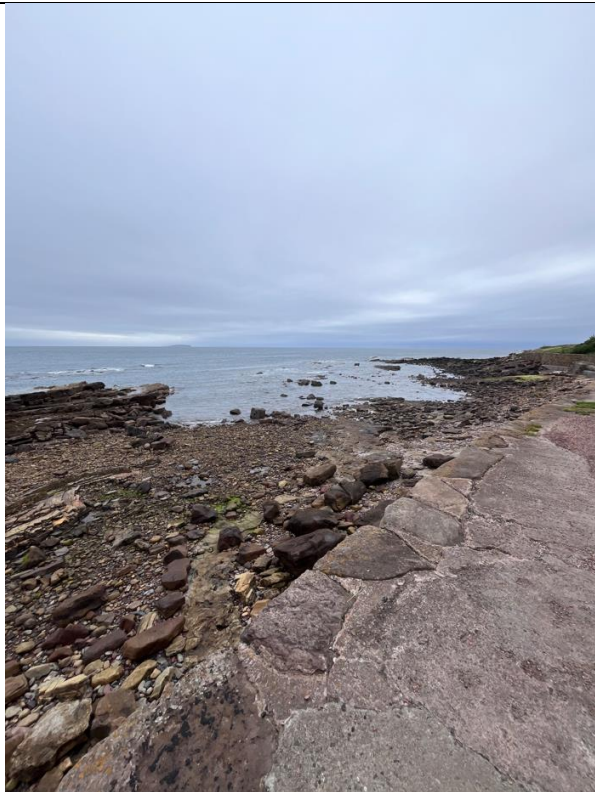
*Figure 48-Surface coverage and foreshore materials at ch341-ch349.*

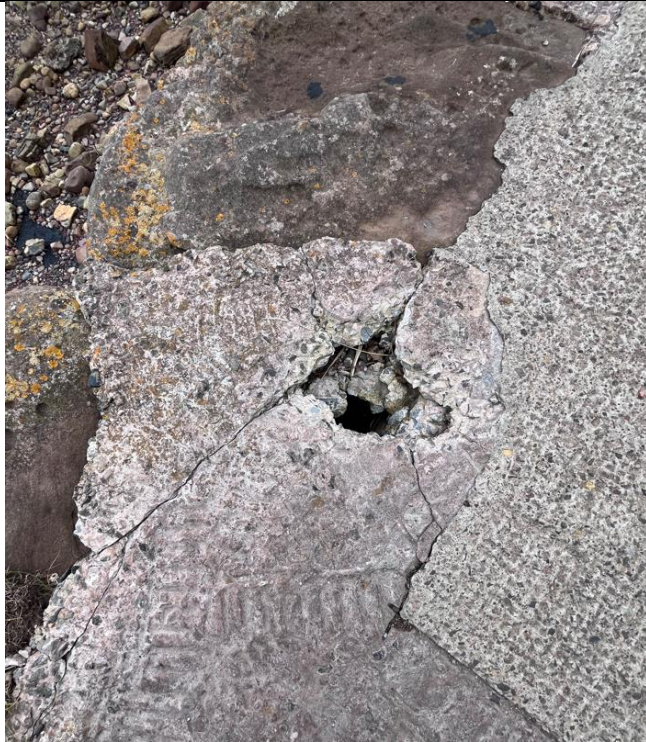
*Figure 49- Area of surfacing missing between ch349-ch358.*

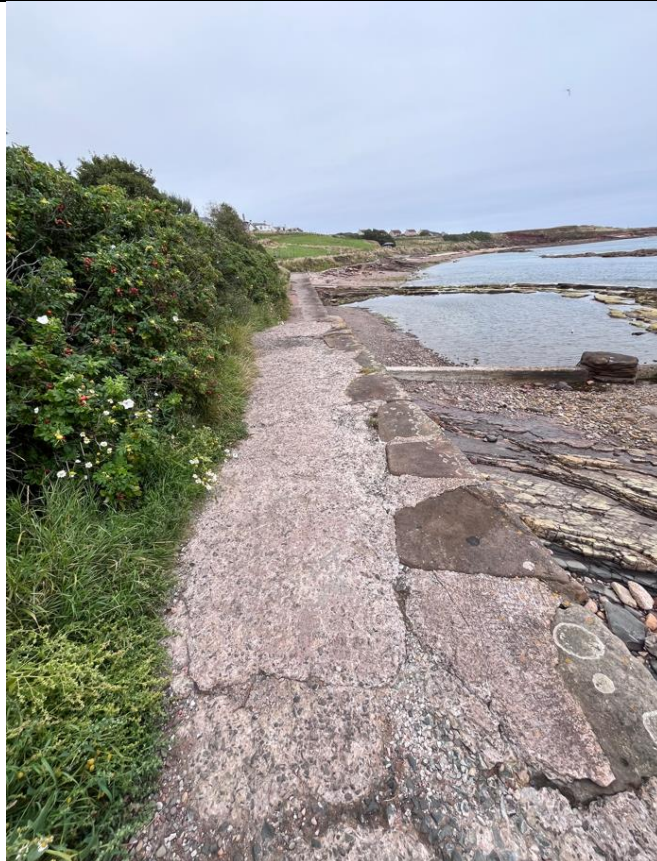
*Figure 50- Cracked path surface between ch358-381.8.*

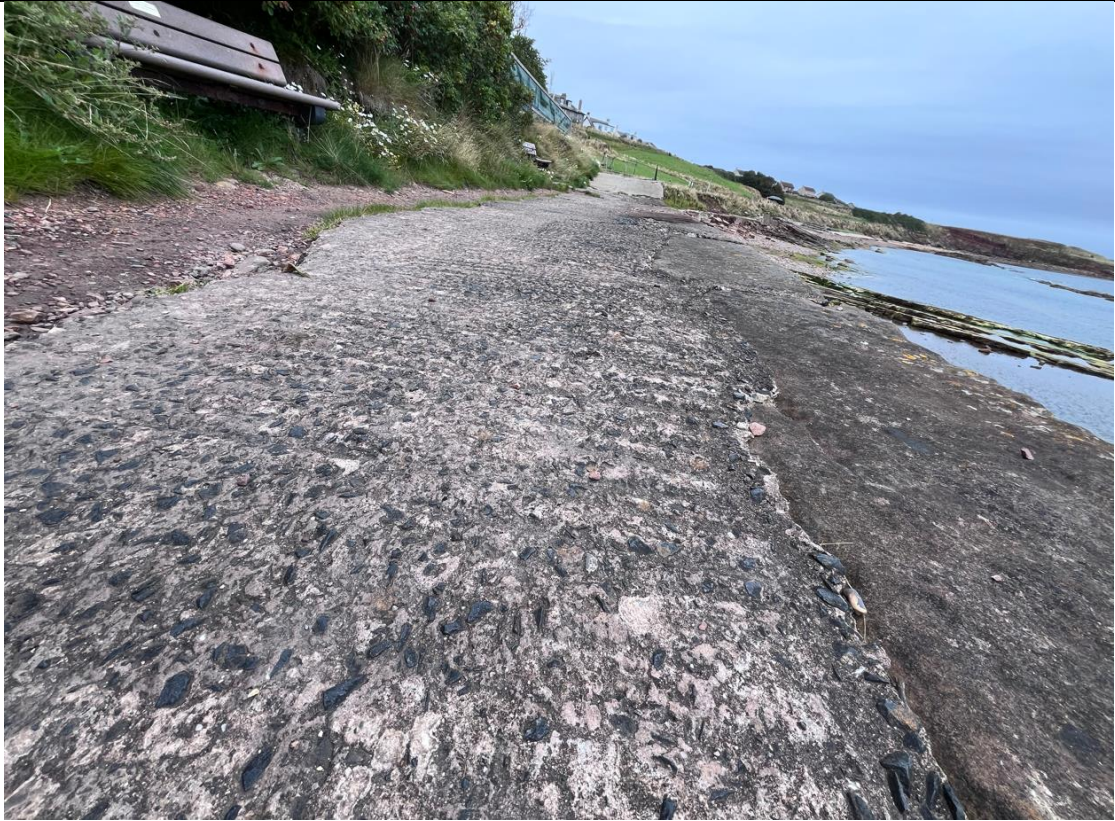
*Figure 51- Path surface between ch384-ch414.*

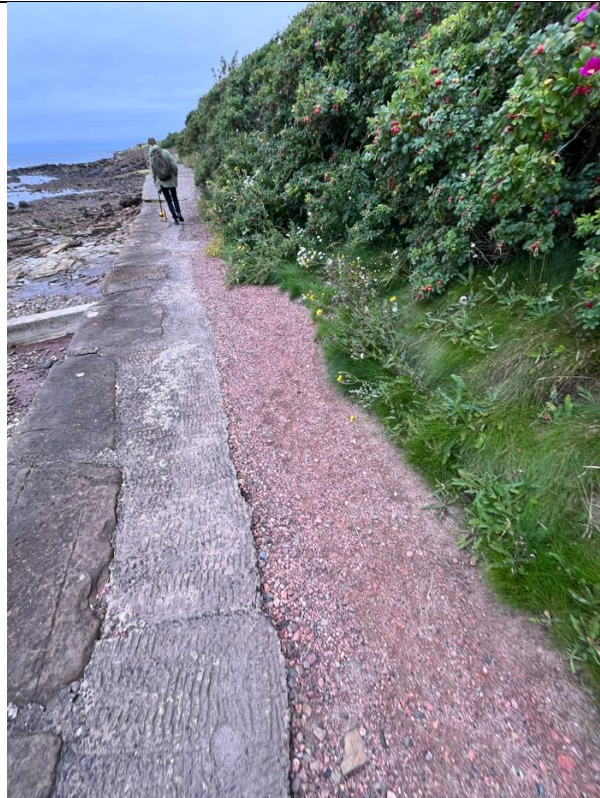
*Figure 52- Path surface between ch384-ch414.*

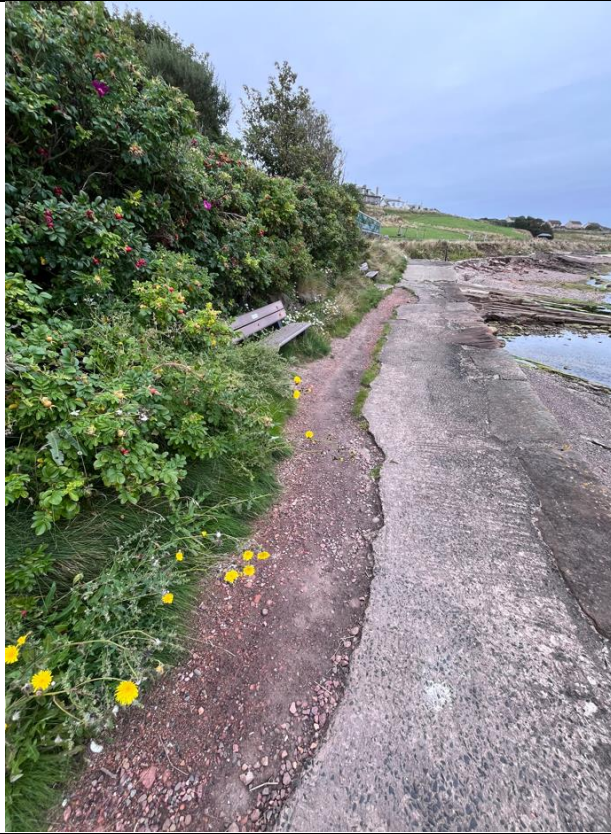
*Figure 53- Path surface between ch384-ch414.*

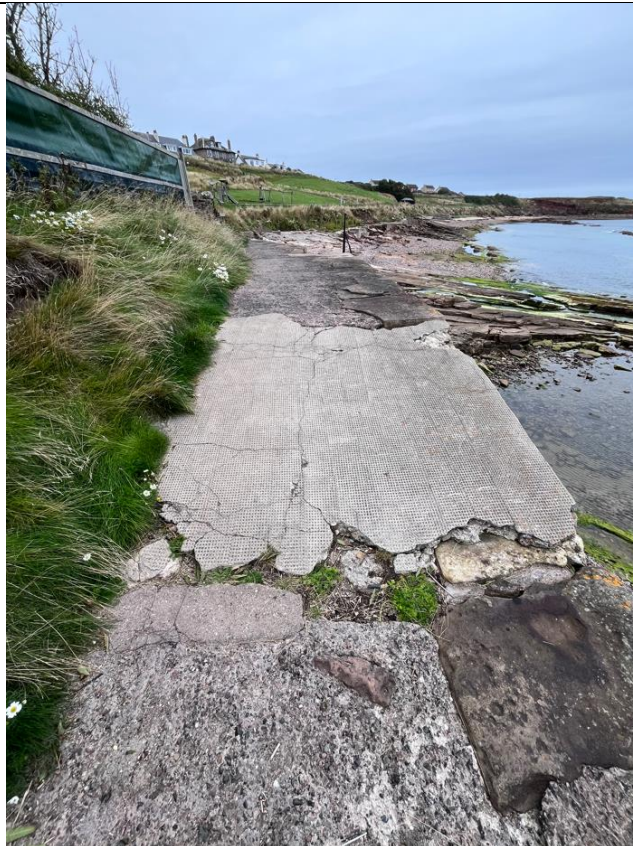
*Figure 54- Damaged ramp/slope to lower area of coastal path located at approximately ch414.*
